**FORM EB 18-2024
MILESTONE INSPECTION REPORT FORM**

Milestone Inspection

**International Village
Condominium, Grenoble
Building**

*3650 Inverrary Dr.,
Lauderhill, FL 33319*

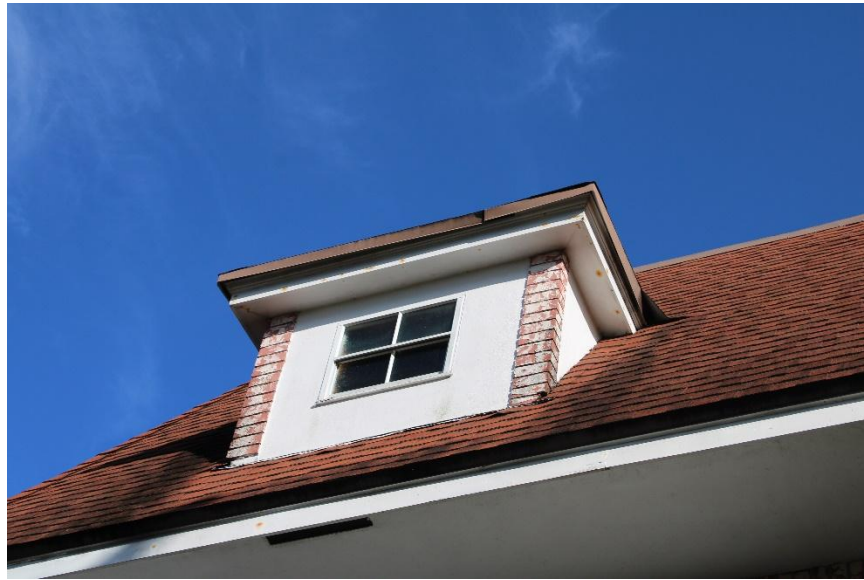
Decorative wooden elements, stone accents, and balcony supports, were inspected. Decorative wooden members were found to need repairs, while the stone accents and balcony supports are in good condition. No signs of settlement, splitting, bulging, cracking, loosening of metal anchors, water entry, or movement of lintels or shelf angles were observed during the inspection.

Photograph 3 – View of the building envelope, featuring a window area and above resting on wood trim combined with decorative veneer stone.

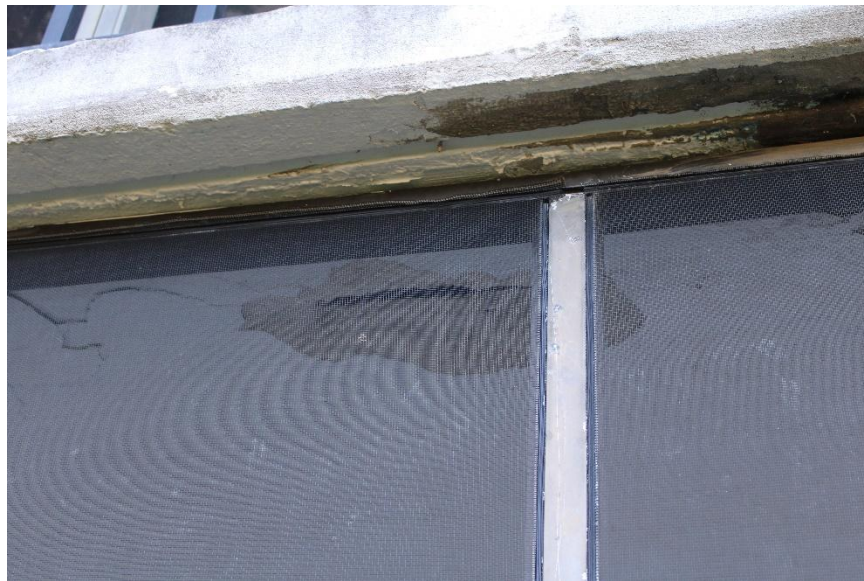
Photograph 4 – View of Overhead Spall.

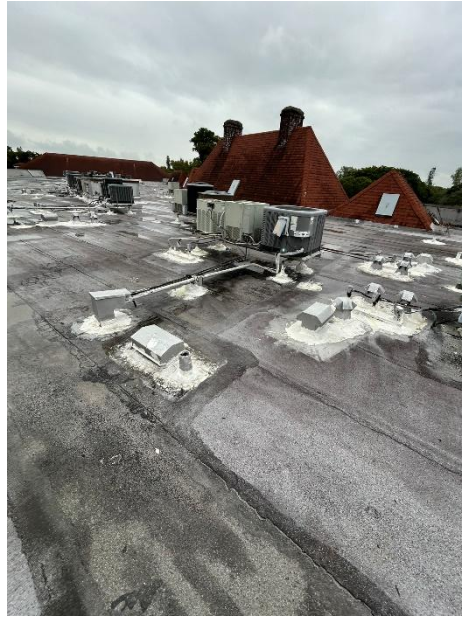
Visible areas show evidence of repair or sealing around roof penetrations. Repairs are needed to address observed issues, and ensure performance and waterproofing integrity.

The roof contains various components, including air conditioning equipment, vent pipes, and other utility connections. The air conditioning units appear to be in good condition, with stable supports. Vent pipes are visible and seem intact, though some areas around the penetrations may require proper sealing and waterproofing.

Photograph 5 – Overview of the roof showing the surface, HVAC equipment, and other utilities. Regular maintenance is required to address wear and ensure proper functionality.

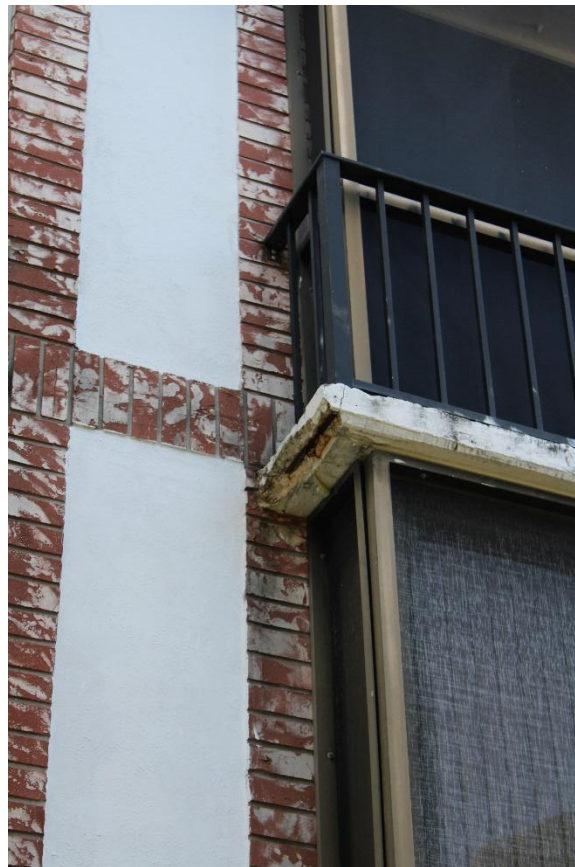
Exposed rebar was found on the balcony edge. Patching is sufficient to address the corrosion in these areas.

The balcony exhibits spalling on the slab and edge, cracking on the slab surface, and localized rebar corrosion on the edge. Repairs, including patching, are required to address these conditions.

Photograph 6 – Visible Spalding and rebar exposed on the outer edge of the balcony.

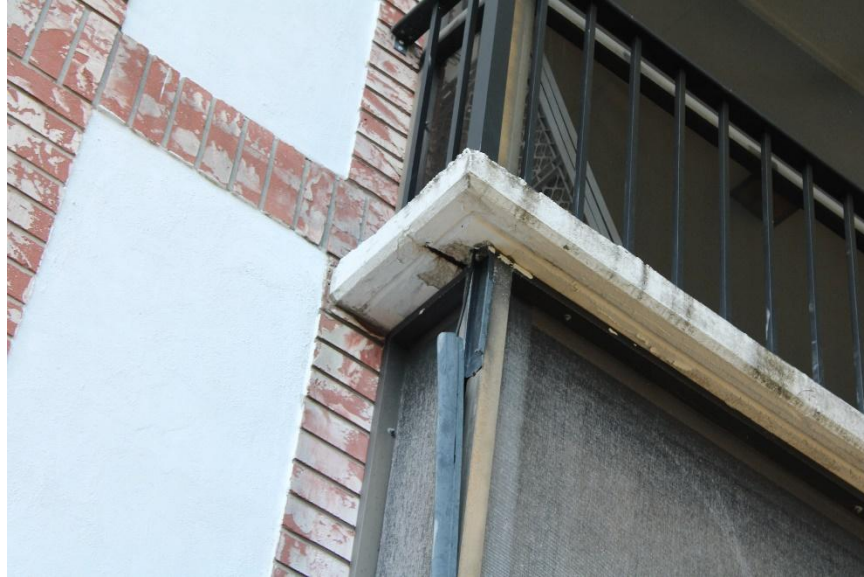
Photograph 7 – Visible Spalding on a balcony.

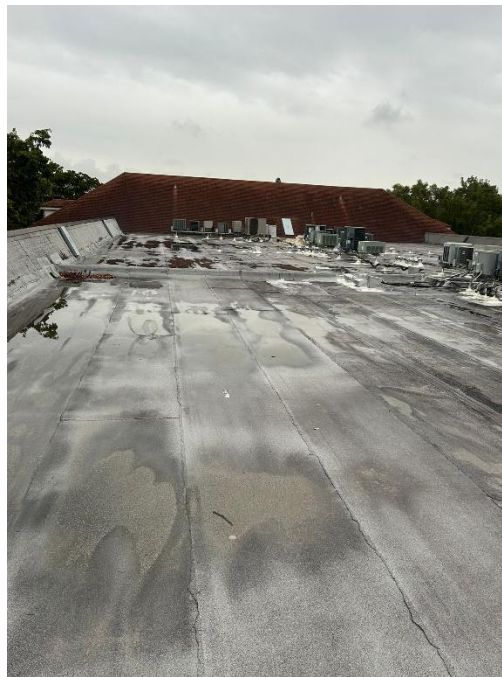
Photograph 8 - Visible cracks, patches, and weathered surfaces on the roof need routine maintenance.
