Milestone Inspection

Survey Report

**International Village Condominium –
Nottingham Building,**
*3760 Inverrary Dr,
Lauderhill, FL 33319*

January 25, 2025

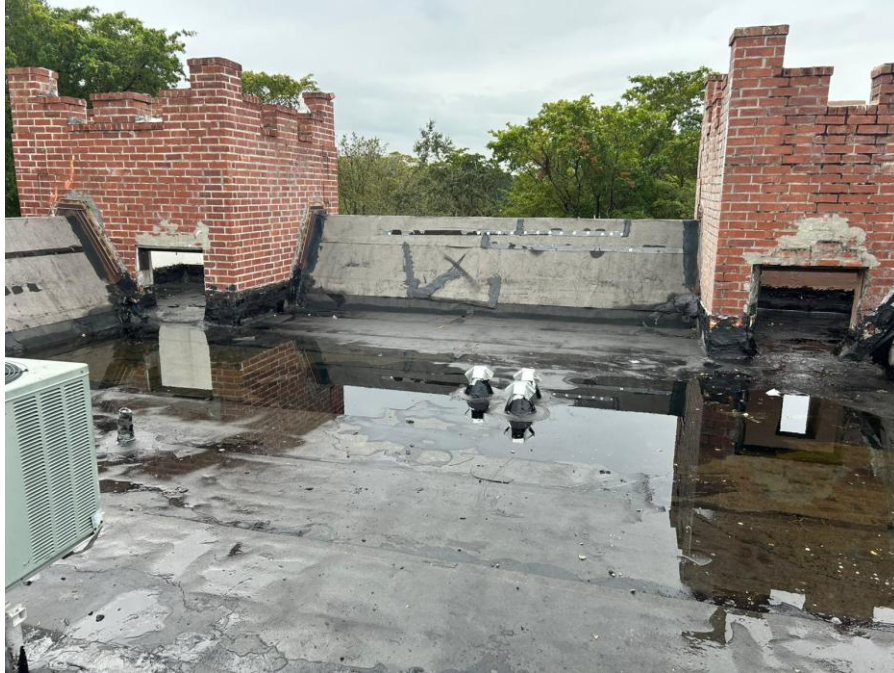
Photograph 5 – View of roof with standing water, patched areas, and exposed concrete. Evidence of drainage issues and recent repair work, possibly to address water infiltration or leaks.

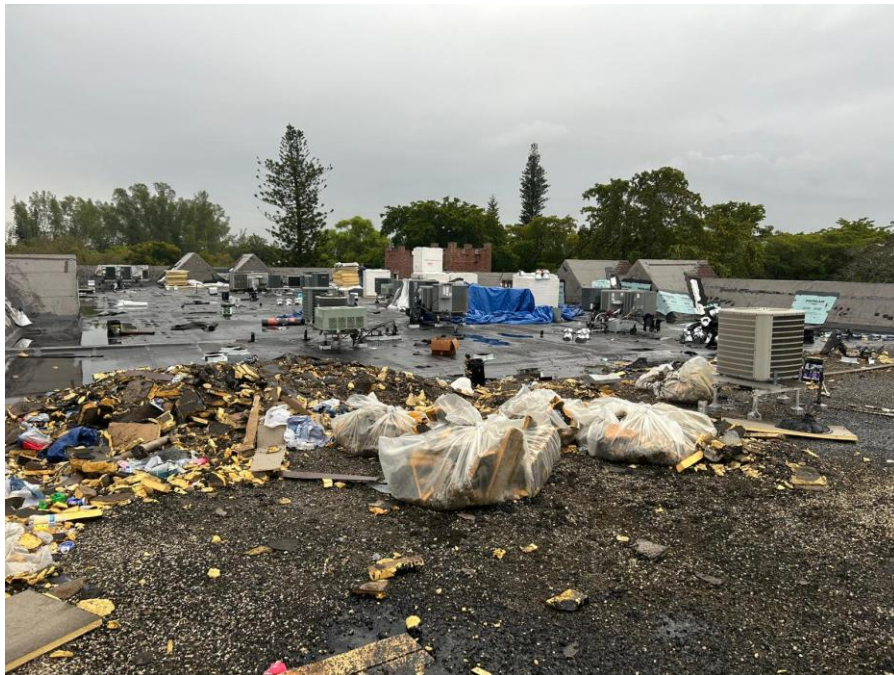
Photograph 6 – View of roof under renovation with construction debris, discarded insulation, and various HVAC units.

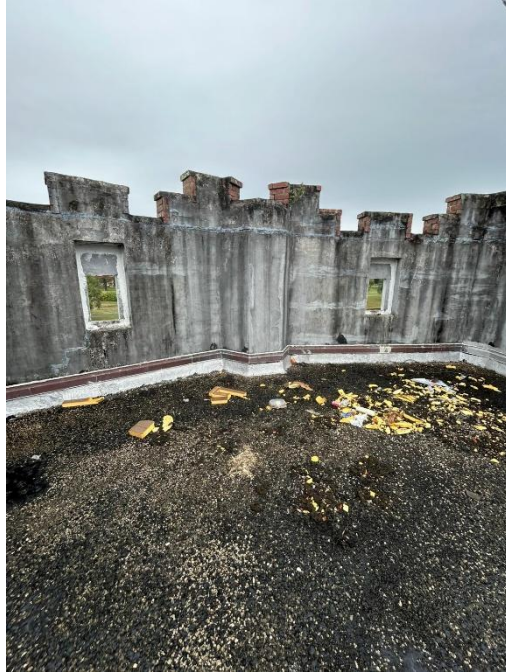
Photograph 7 - Rooftop area with exposed concrete parapets showing signs of weather and scattered debris. Evidence of ongoing maintenance
