Milestone Inspection

Survey Report

**International Village Condominium –
Orleans Building,
3680 Inverrary Dr,
Lauderhill, FL 33319**

January 25, 2024

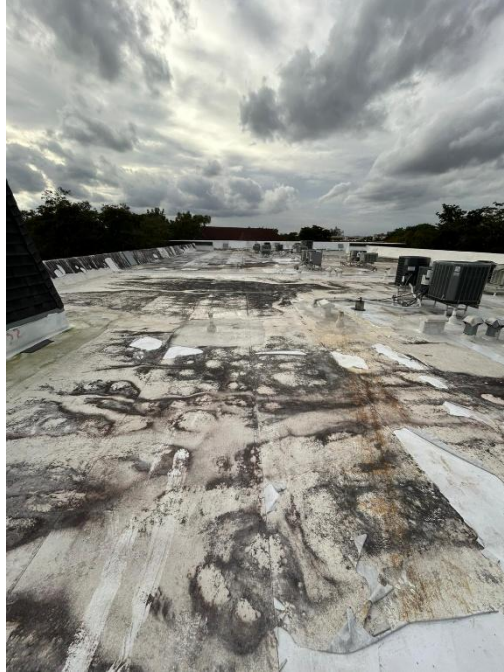
Photograph 5 – View of aged flat roof with deteriorated and discolored membrane, showing signs of wear, peeling, and previous patchwork.

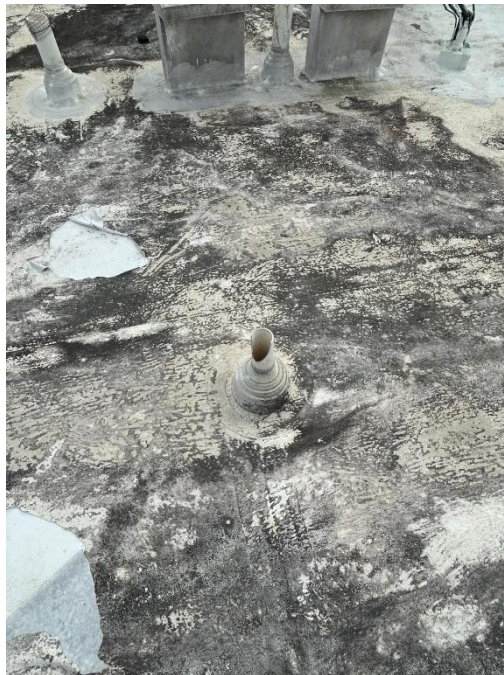
Photograph 6 -View of vent pipes and deteriorated membrane showing discoloration, patchwork, and signs of aging. Sealant has been applied around penetration, indicating efforts to manage leaks or water infiltration.

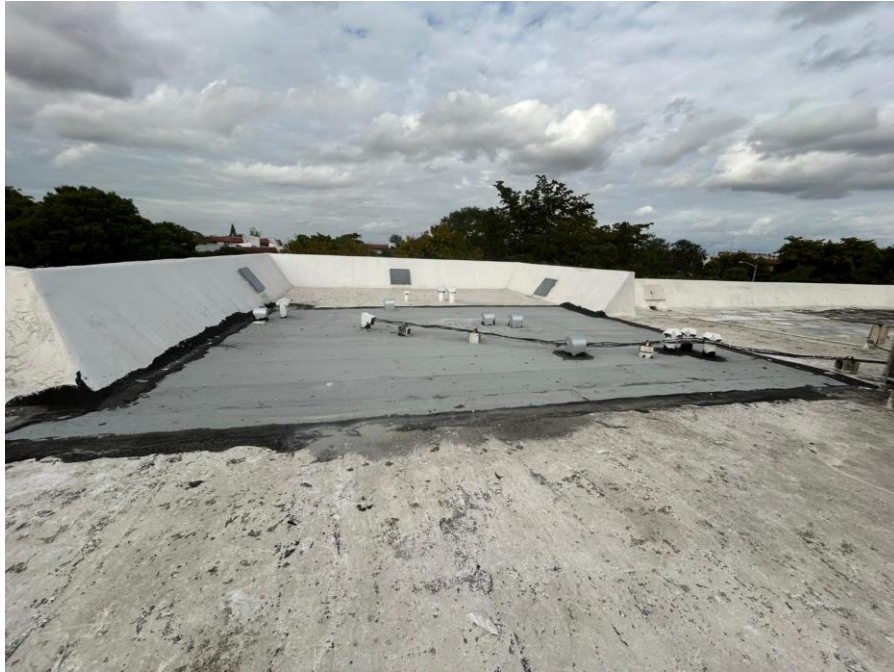
Photograph 7 – View of roof with coated parapet walls and a repaired membrane section secured with waterproofing sealant.
