## Milestone Inspection

## Survey Report

**International Village Condominium –  
St. Moritz Building,  
3710 Inverrary Dr,  
Lauderhill, FL 33319**

January 25, 2025

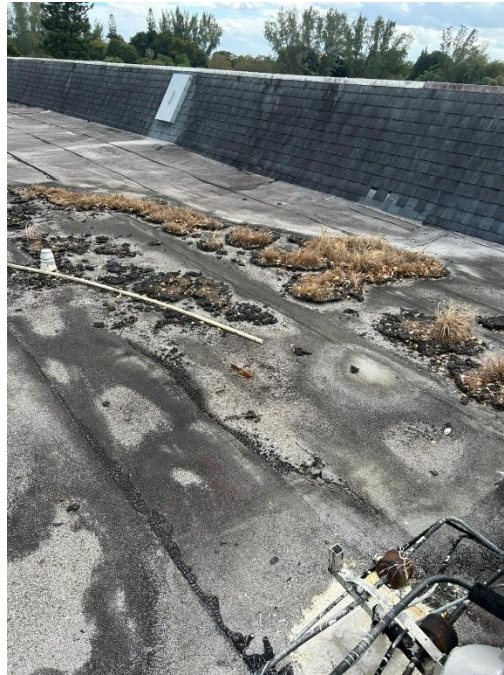
*Photograph 5 – View of roof with overgrown vegetation, deteriorated membrane, and visible signs of neglect.*

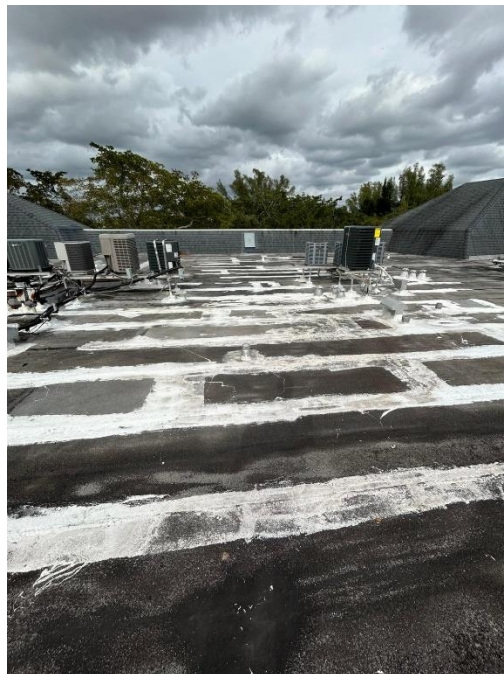
*Photograph 6 – View of multiple HVAC units and extensive patchwork, featuring white sealant applied to seams and cracks. The membrane shows signs of aging and previous repairs, suggesting ongoing maintenance.*

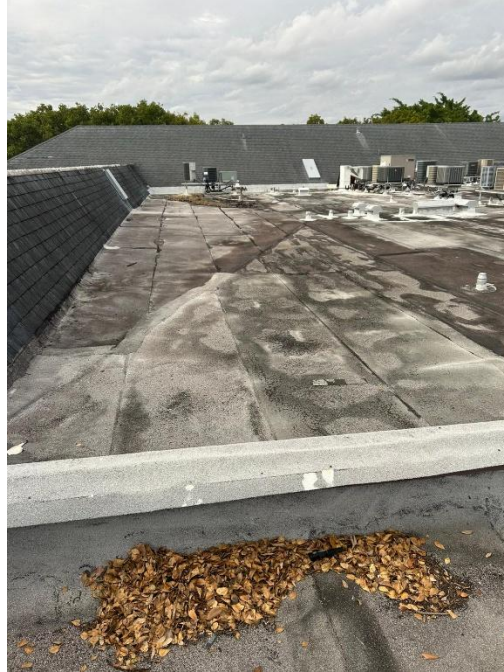
*Photograph 7 - Mansard roof with shingle cladding and a flat central section showing signs of wear, discoloration, and previous repairs. Accumulation of leaves and debris suggests potential drainage issues*
