**FORM EB 18-2024**  
**MILESTONE INSPECTION REPORT FORM**

**PHASE 1 - Milestone Inspection**

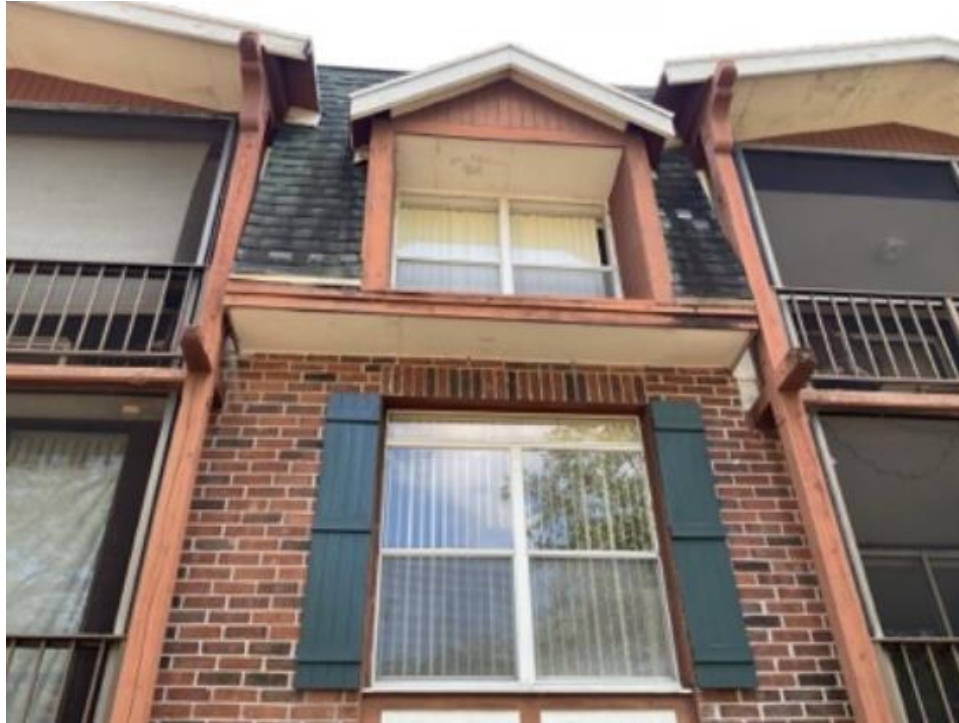
*Photograph 3 – View of underside of soffit, sign of water damage.*

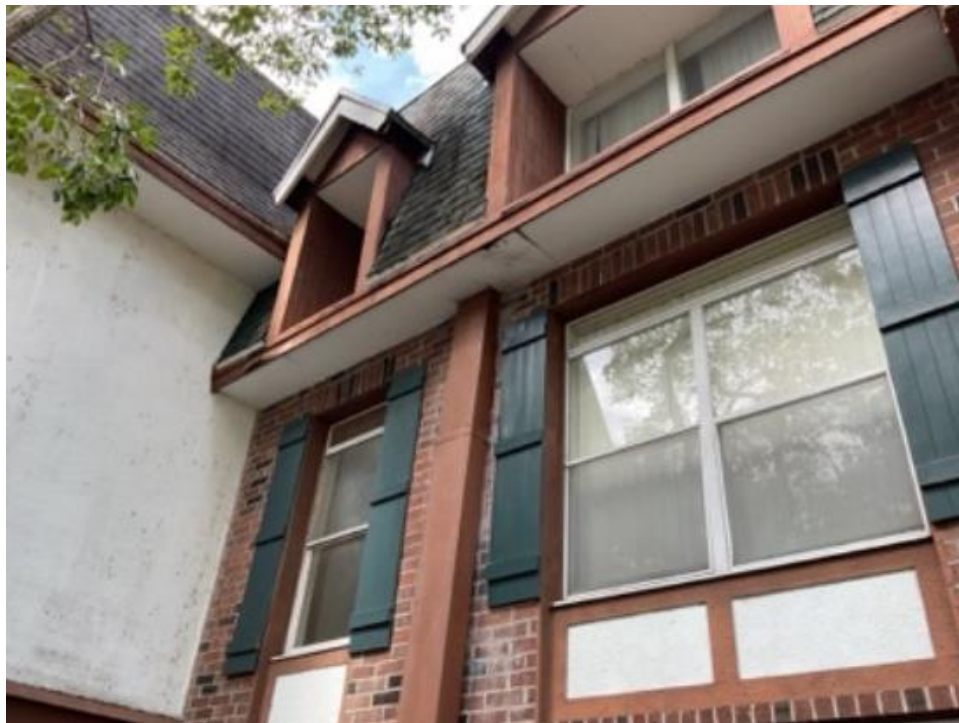
*Photograph 4 – Overview of the underside of roof showing the soffit, signs of water damage.*

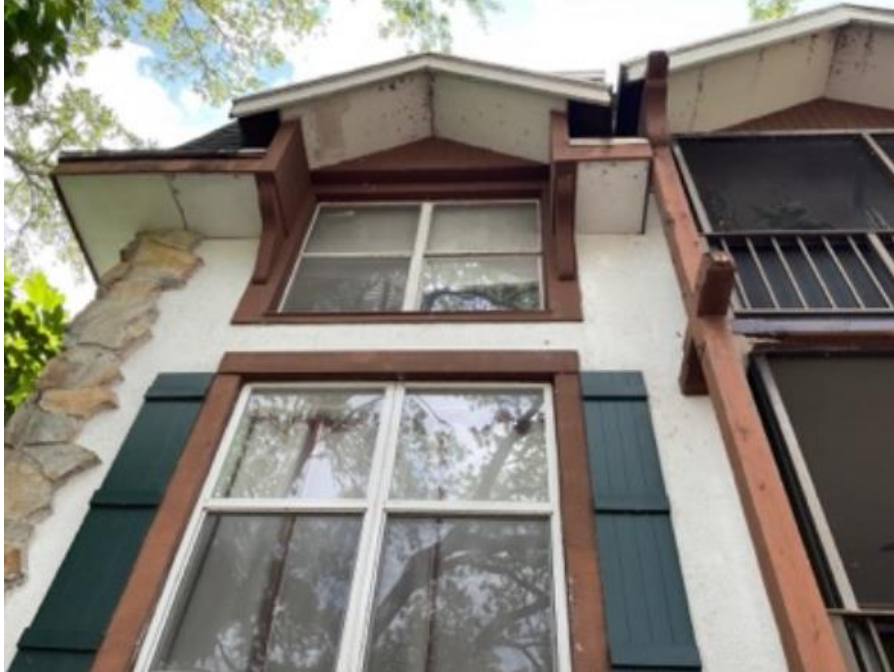
*Photograph 5 - Overview of the underside of roof showing the soffit, signs of water damage.*

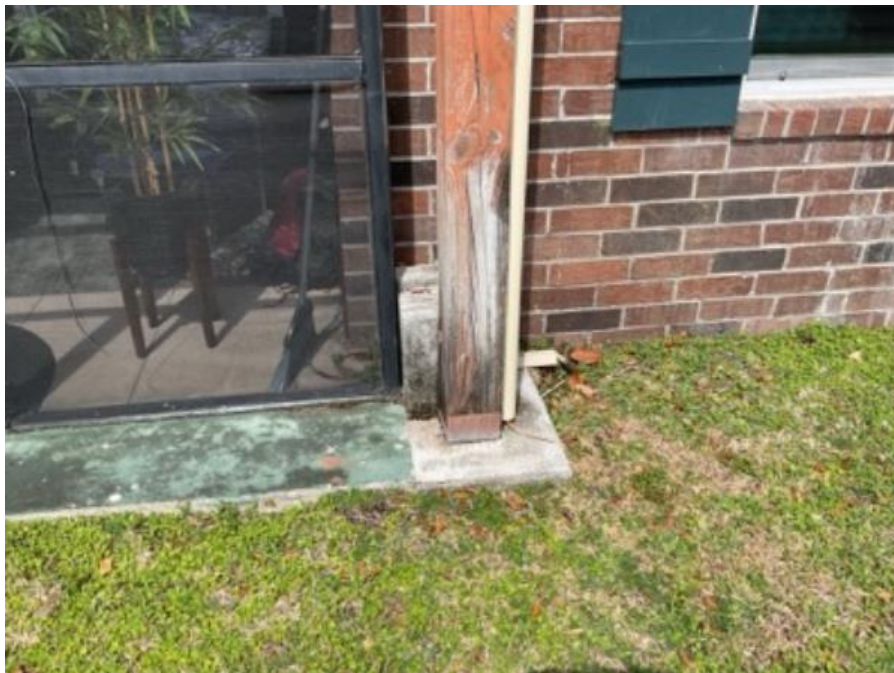
*Photograph 6 -- Visible growth of vegetation on the outer edge of the balcony.*

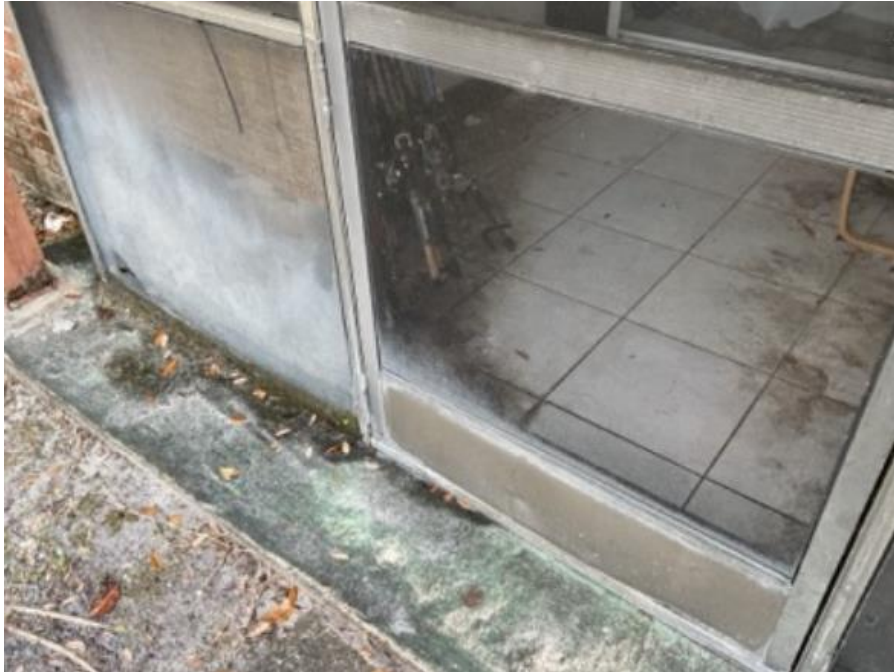
*Photograph 7 - Visible growth of vegetation, pooling water, and source of water damage.*

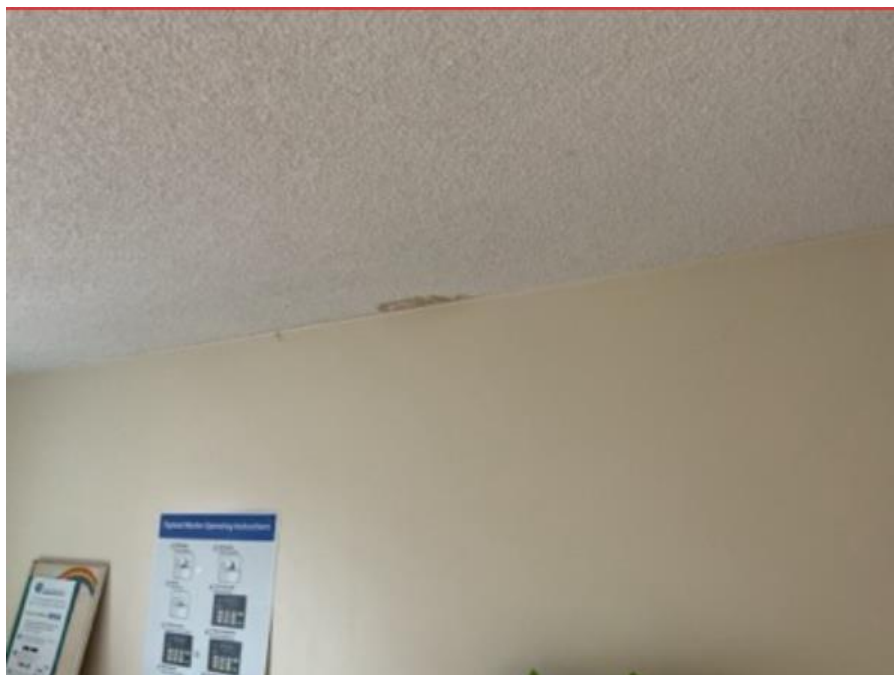
*Photograph 8 - View of laundry ceiling on 3<sup>rd</sup> floor with evidence of previous water damage.*

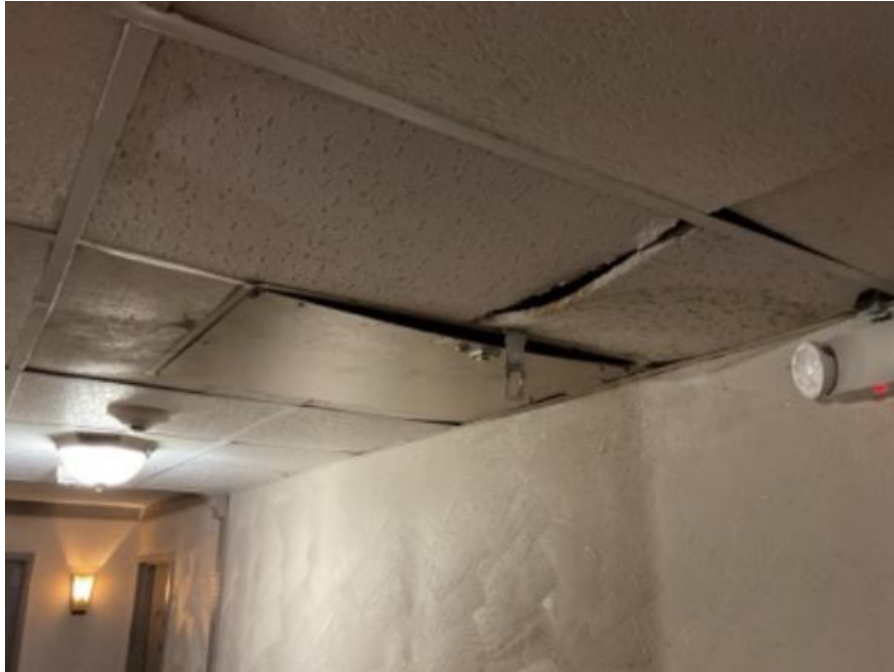
*Photograph 9 - View of suspended ceiling on 3<sup>rd</sup> floor corridor with evidence of previous water damage.*

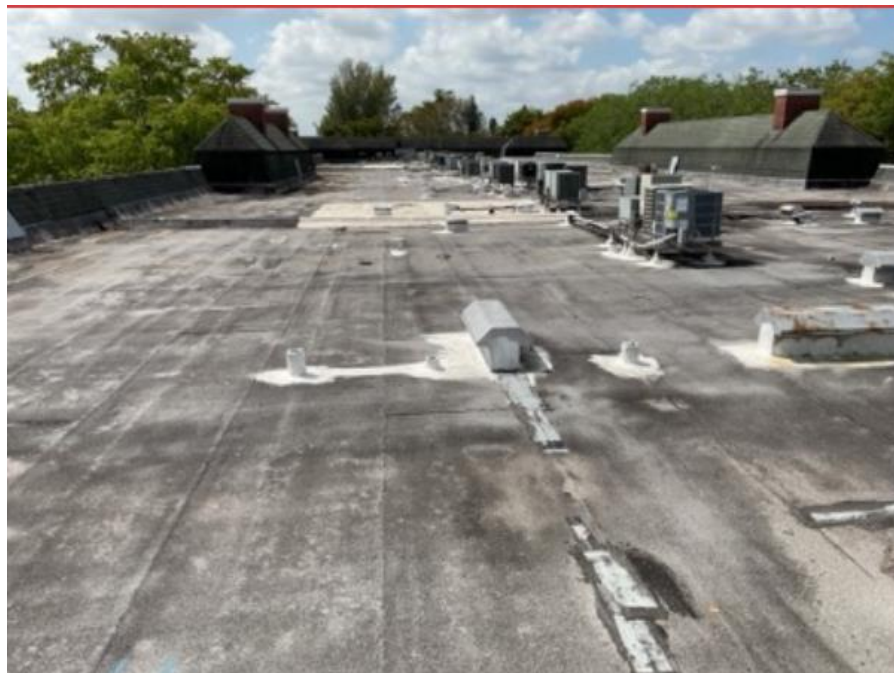
*Photograph 10 – View of roof repair with multiple patches and sealant applications, showing areas of asphalt-based waterproofing membrane and white sealant, likely addressing previous leaks or cracks.*

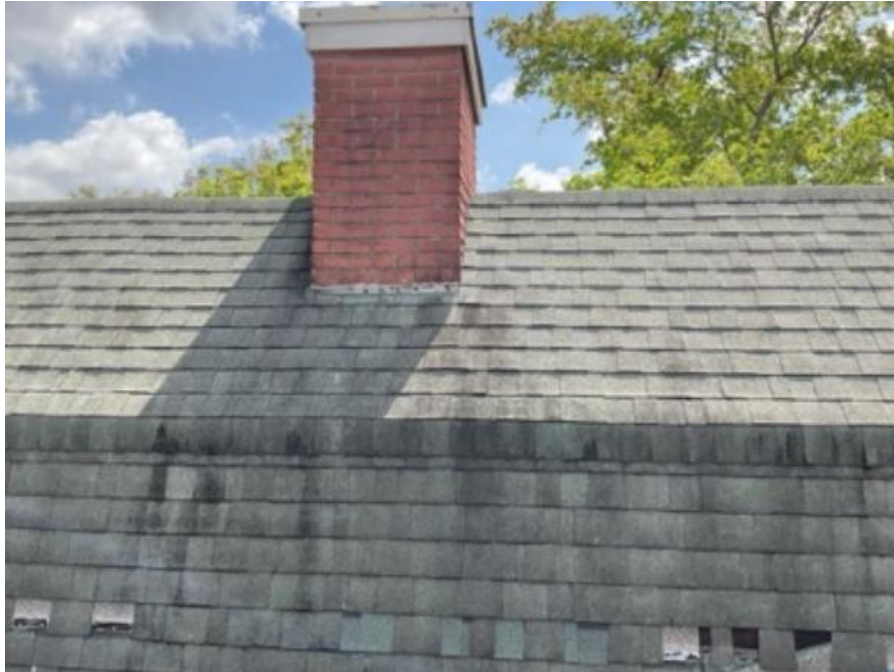
*Photograph 11 – compromised mansard parapet roof.*

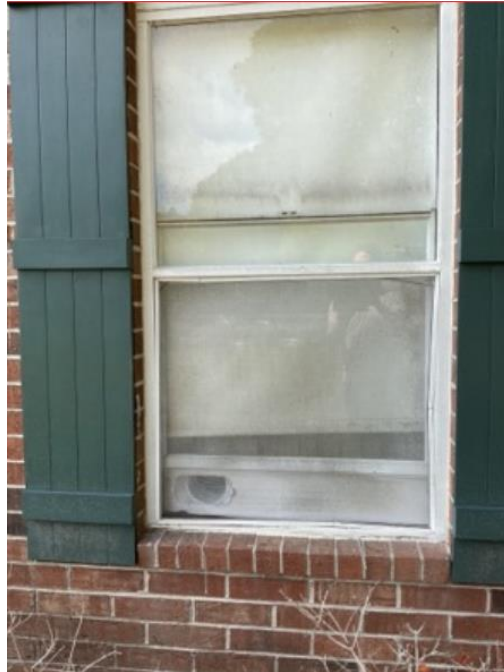
*Photograph 13- typical window, insufficient protection and improperly sealed.*

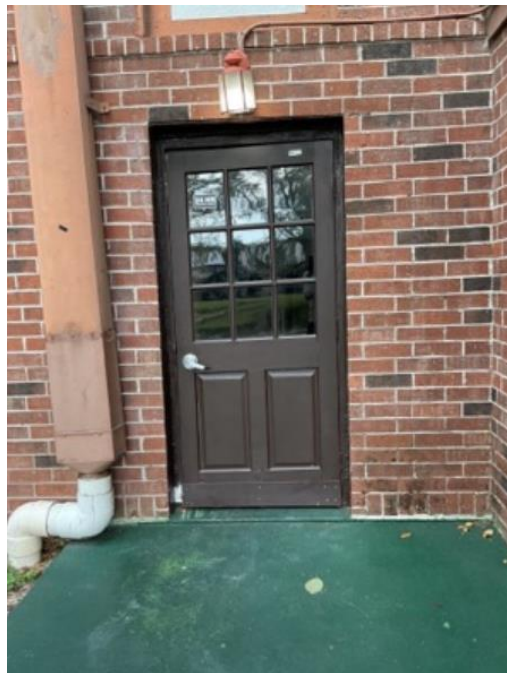
*Photograph 14 – typical door, insufficient protection and improperly sealed*

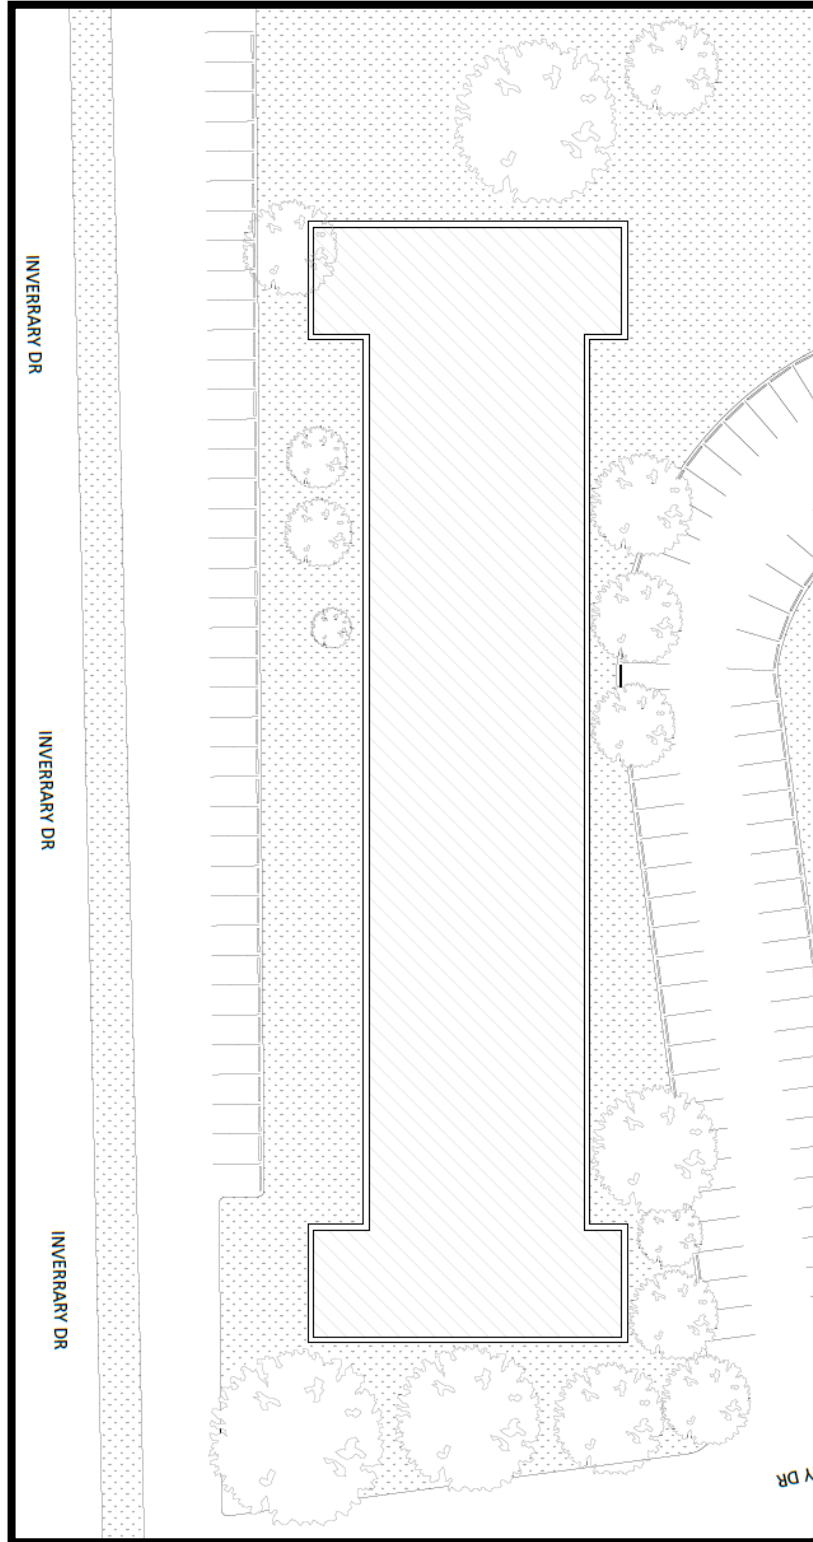
Figure 4: Typical Site Plan
