**FORM EB 18-2024
MILESTONE INSPECTION REPORT FORM**

Milestone Inspection

Survey Report

International Village Condominium –
Zurich Building,
3750 Inverrary Dr,
Lauderhill, FL 33319

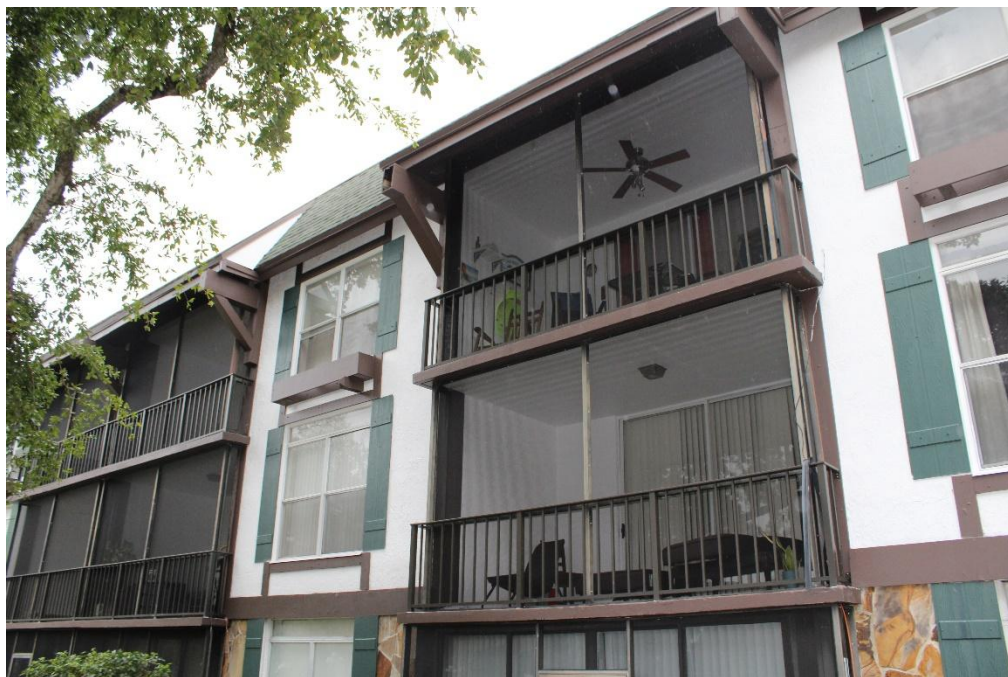
The balcony is in good condition, with no visible cracks, deflections, or signs of structural distress. There is no evidence of water infiltration, staining, or mold. Railings and guardrails are secure and free of rust.

The guardrails are located on the balconies and stairways. They are constructed of metal and are in good condition, with no visible signs of damage or deterioration.

Photograph 2 – Typical view of the balconies and railing system.

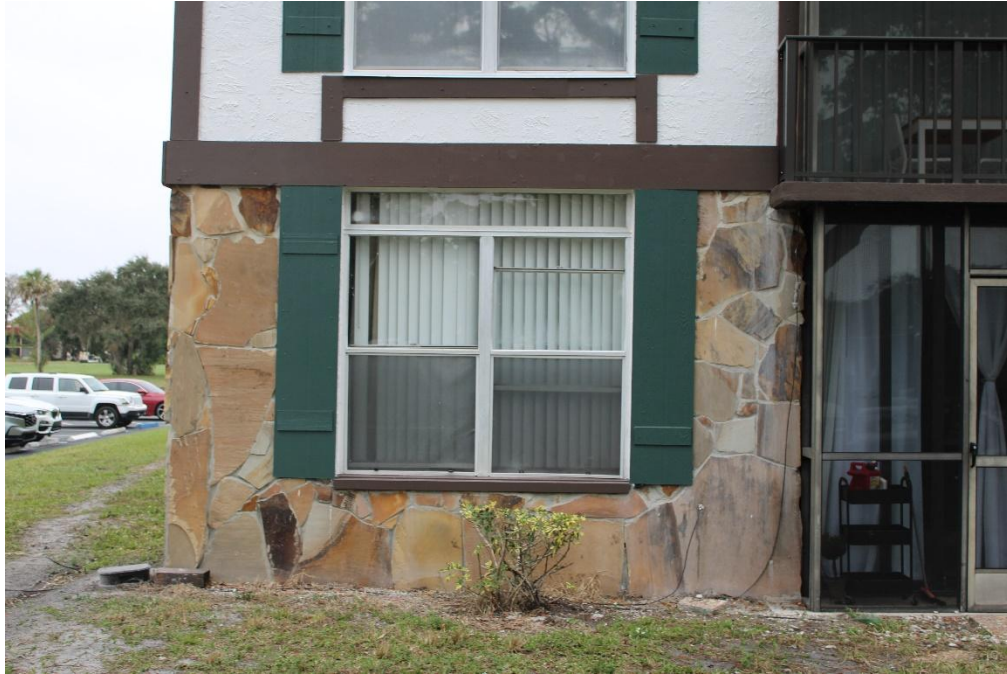
The exterior walls of the building feature a stucco finish with decorative stone accents, which are adhered to the wall using a mortar or adhesive bonding system. These elements are in good condition and appear secure.

Photograph 3 – View of the building envelop, featuring a stucco finish combined with decorative stone cladding.

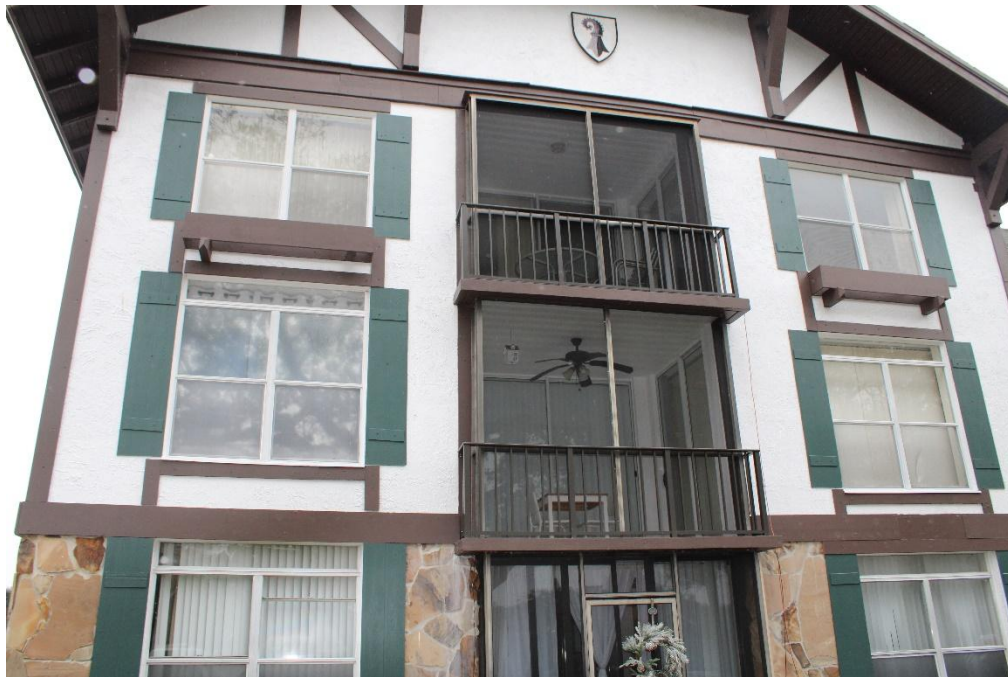
The window system is in good condition, with intact glass, secure frames, and no signs of damage or leakage.

Wooden architectural elements, including trims, beams, and balcony supports, are attached with adhesive and enhance the building's aesthetic appeal. These wooden components are in good condition.

Photograph 4 – Typical view of windows system, balconies and decorative wooden features.

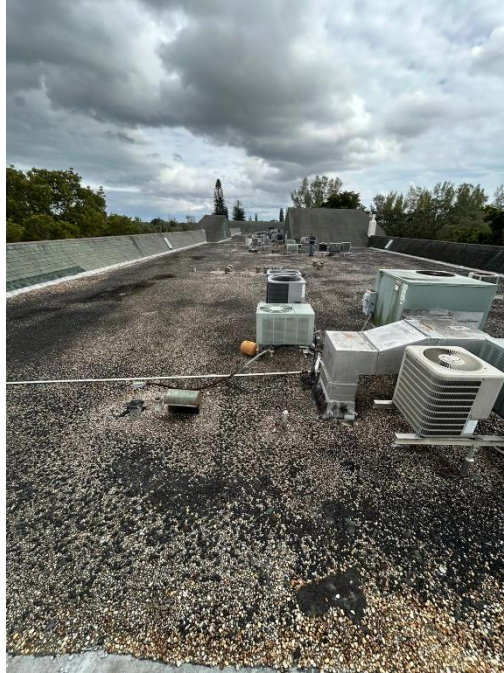
Visible areas show evidence of repair or sealing around roof penetrations. Repairs are needed to address observed issues, and ensure performance and waterproofing integrity.

The roof contains various components, including air conditioning equipment, vent pipes, and other utility connections. The air conditioning units appear to be in good condition, with stable supports. Vent pipes are visible and seem intact, though some areas around the penetrations may require proper sealing and waterproofing.

Photograph 5 – Overview of the roof showing gravel surface, HVAC equipment, and other utilities. Regular maintenance is required to address wear and ensure proper functionality.

The roof, however, requires immediate repairs to address wear and maintain its waterproofing and structural integrity. Timely maintenance and periodic inspections of the roof and other structural elements are recommended to prevent further deterioration and ensure the long-term stability and safety of the building.

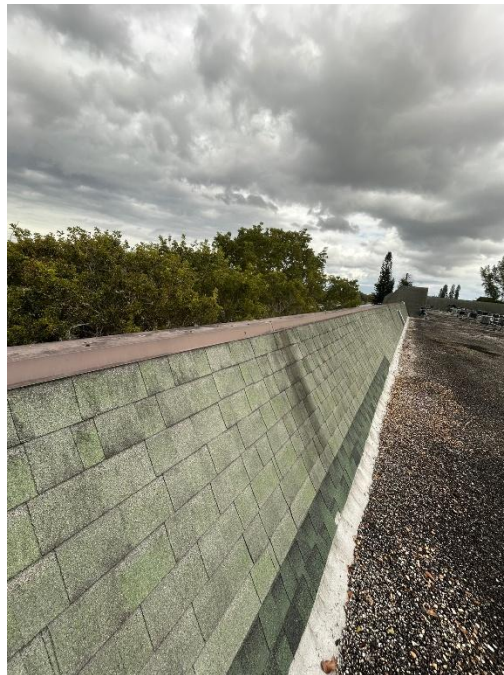
The mansard roof is constructed with a sloped shingle finish, transitioning to a concrete base at the roof level. The shingles appear to be in generally good condition, with no major signs of damage or displacement. The metal coping along the top edge is securely in place and free from corrosion. Portions of the concrete base at the bottom of the parapet shows cracks. Overall, the parapet is in good condition.

Photograph 6 – View of Mansard Roof.
