PHASE 1 - Milestone Inspection

Inspection Firm or Individual

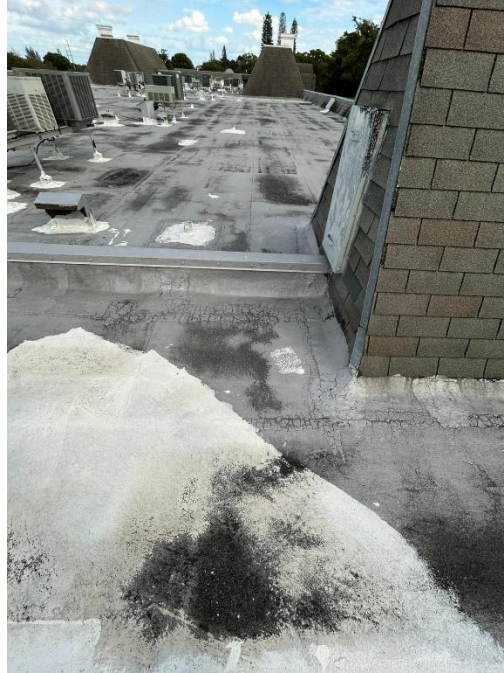
Photograph 5 - Overview of the roof showing visible wear, patching and discoloration, around HVAC units and vent penetrations

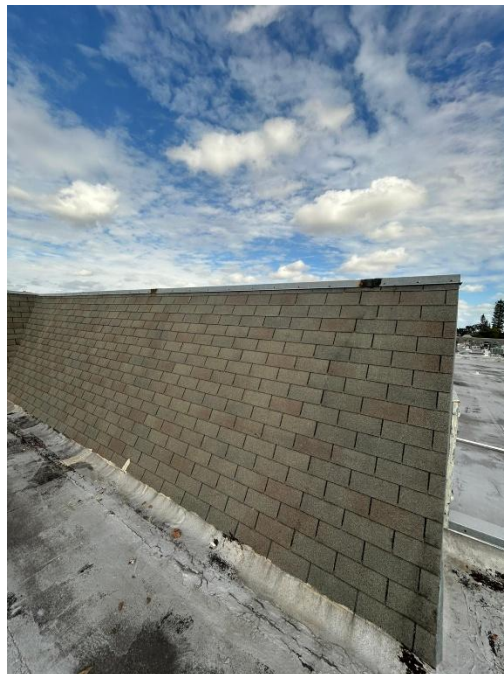
Photograph 6 - View of the building's mansard roof with asphalt shingles and metal coping.

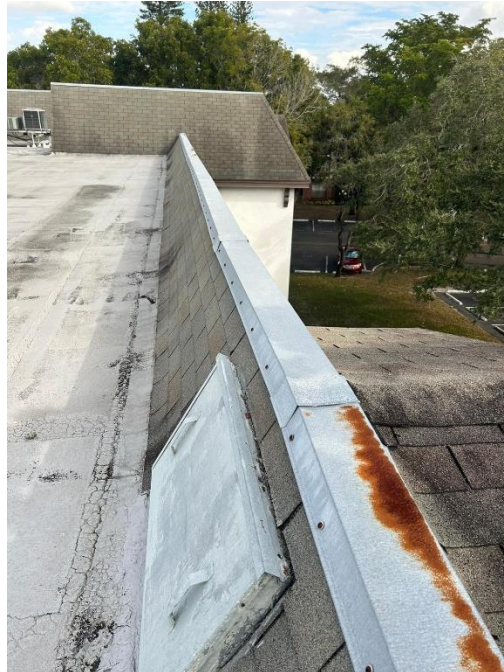
Photograph 7 – View of metal coping with visible rust along the edge of the roof, adjacent to a weathered access hatch and asphalt shingles.

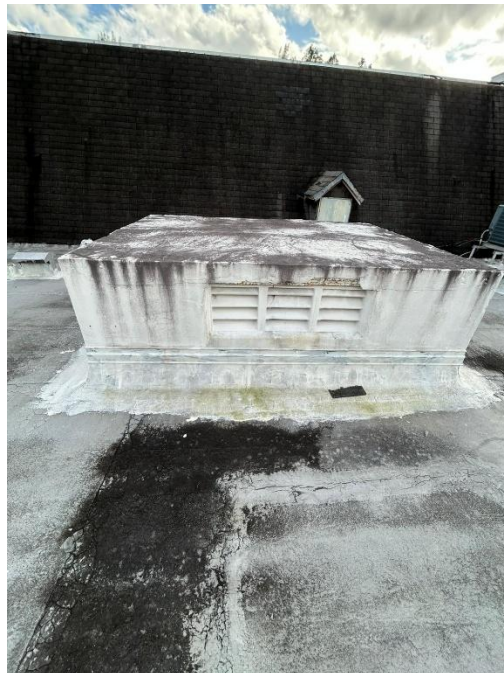
Photograph 8 - Weathered rooftop ventilation structure with visible discoloration, cracks, and patching on the surrounding flat roof surface
