## PHASE 1 - Milestone Inspection

a. Name on Title: International Village Condominium - Yorkshire Building

b. Street Address: 3690 Inverary Dr, Lauderdale, FL 33319

Milestone Inspection

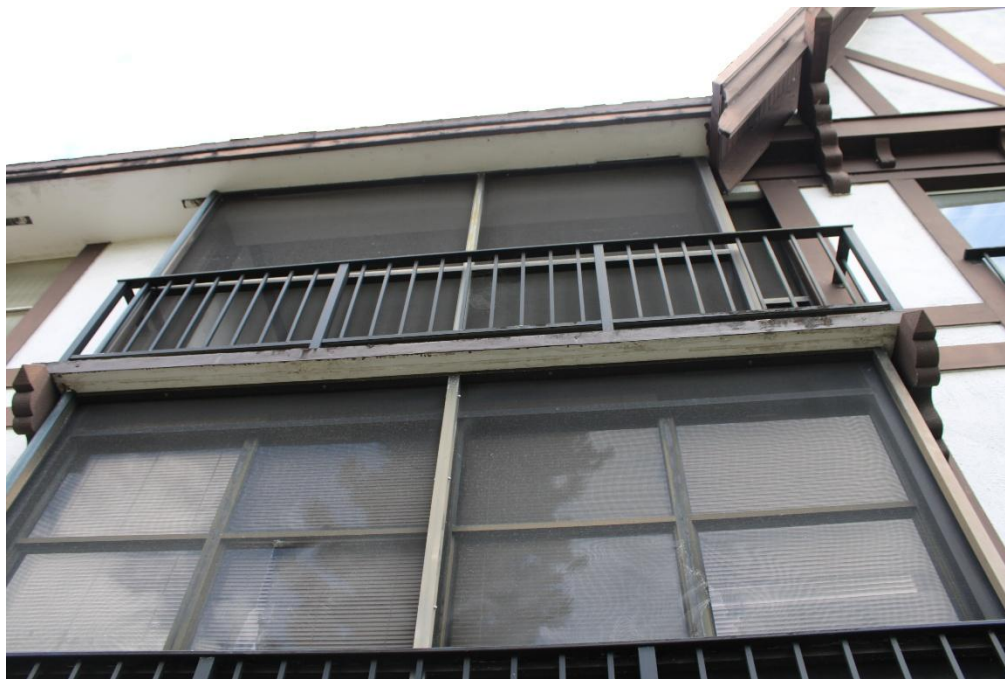
The guardrails are located on the balconies and stairways. They are constructed of metal and are in good condition, with no visible signs of damage or deterioration.

*Photograph 2 - Typical view of the balconies and railing system.*

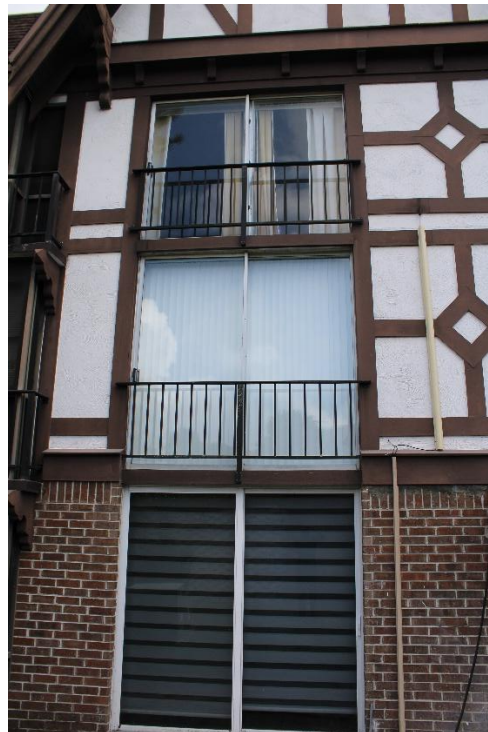
Decorative wooden elements, stone accents, and balcony supports, were inspected. Decorative wooden members were found to need repairs, while the stone accents and balcony supports are in good condition. No signs of settlement, splitting, bulging, cracking, loosening of metal anchors, water entry, or movement of lintels or shelf angles were observed during the inspection.

*Photograph 4 - Typical view of windows system, balconies and decorative wooden features.*

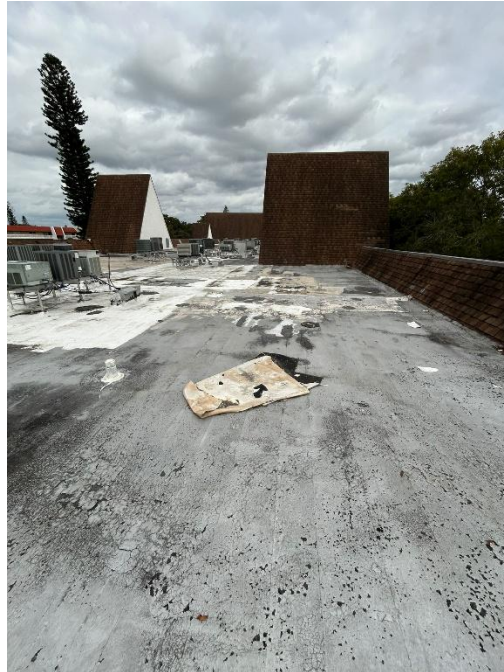
Visible areas show evidence of repair or sealing around roof penetrations. Repairs are needed to address observed issues, and ensure performance and waterproofing integrity.

*Photograph 5 - Overview of the roof showing Aged coatings and scattered debris.*

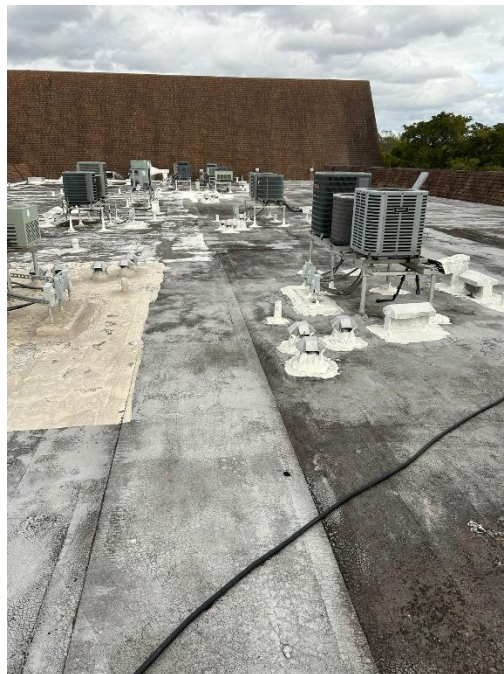
The roof contains various components, including air conditioning equipment, vent pipes, and other utility connections. The air conditioning units appear to be in good condition, with stable supports. Vent pipes are visible and seem intact, though some areas around the penetrations may require proper sealing and waterproofing.

*Photograph 6 - Multiple HVAC units, vents, and utility installations, showing signs of weathering, patch repairs, and varying roofing materials.*

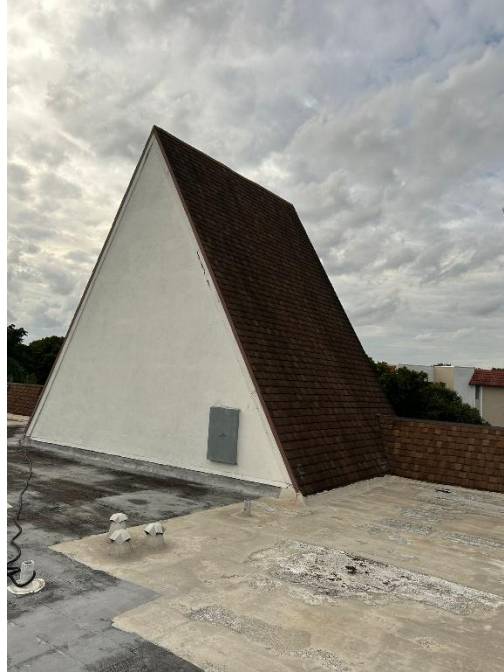
The mansard roof is constructed with a sloped shingle finish, transitioning to a concrete base at the roof level. The shingles appear to be in generally good condition, with no major signs of damage or displacement. The metal coping along the top edge is securely in place and free from corrosion. Portions of the concrete base at the bottom of the parapet shows cracks. Overall, the parapet is in good condition.

*Photograph 7 - View of Mansard Roof.*

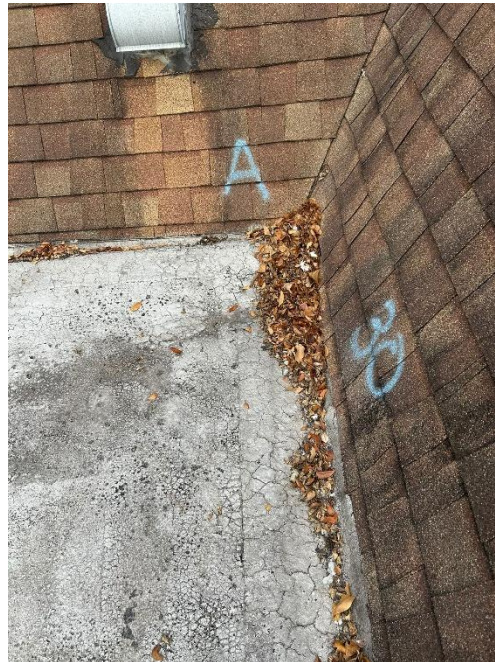
The scuppers are installed along the sloped mansard roof, discharging water from the flat roof section. The scuppers appear functional but may require further inspection for clogs or damage, as debris is present near the outlet, which could obstruct drainage. The surrounding areas show signs of water staining and wear on the roofing material, indicating potential water flow issues or inadequate drainage.

*Photograph 8 - Visible cracks, patches, and weathered surfaces. Adjacent sloped shingle roofing shows signs of wear, with debris accumulation along the edge.*
