# ADVANCED

STRUCTURAL SOLUTIONS

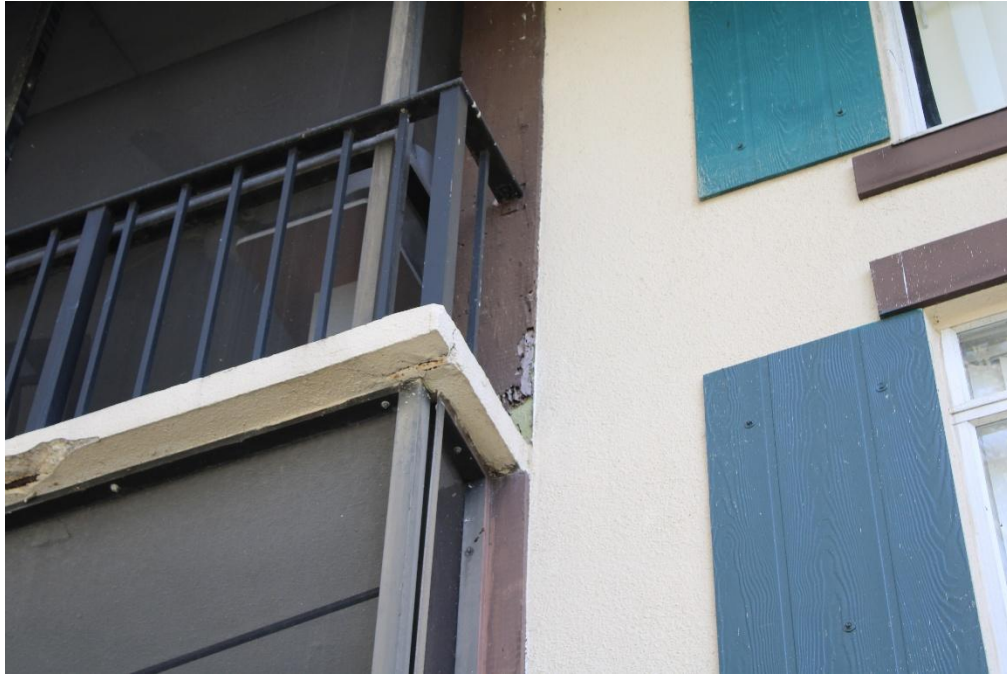
*Photograph 3 – View of balcony edge spalling with exposed rebar.*

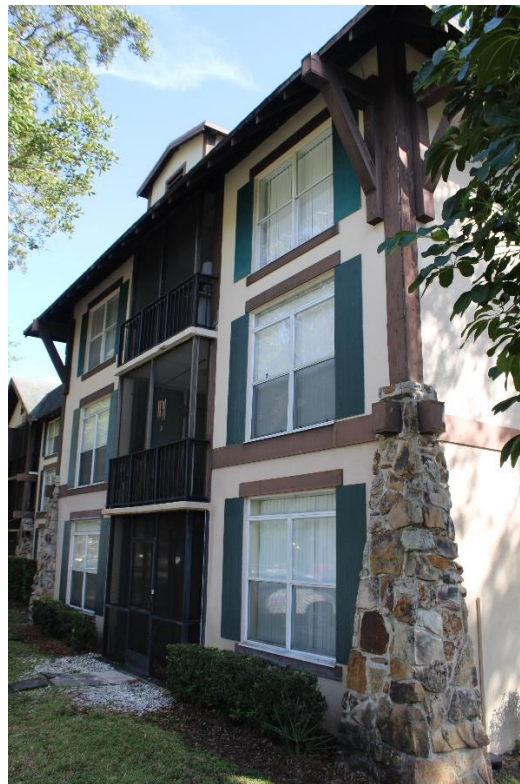
*Photograph 4 – View of architectural wooden fixtures and veneer wall.*

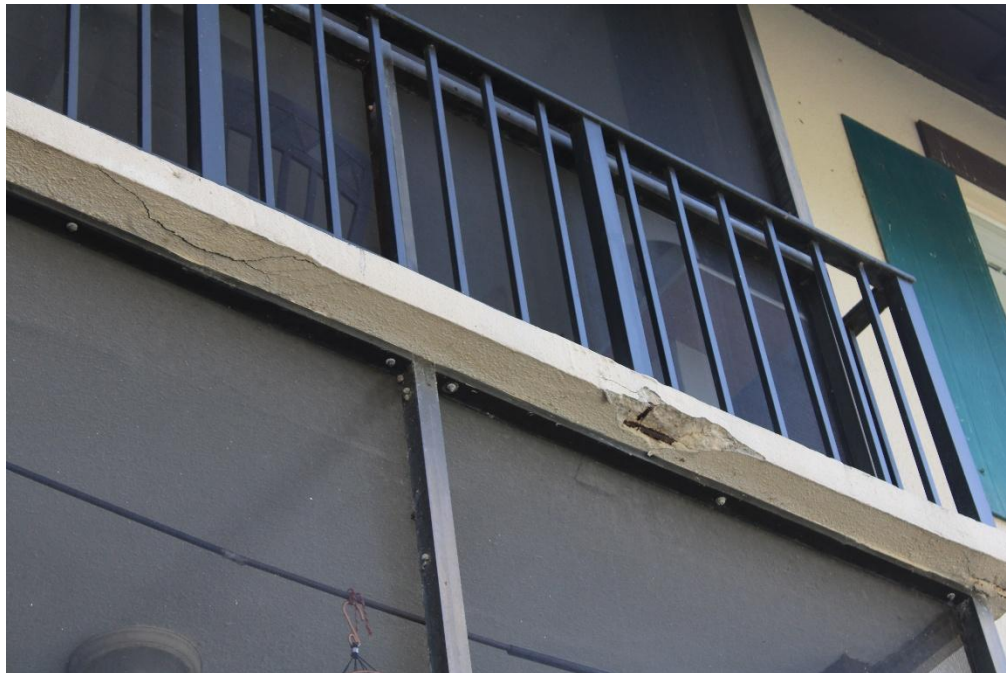
*Photograph 6 – View of balcony edge spall with exposed rebar.*

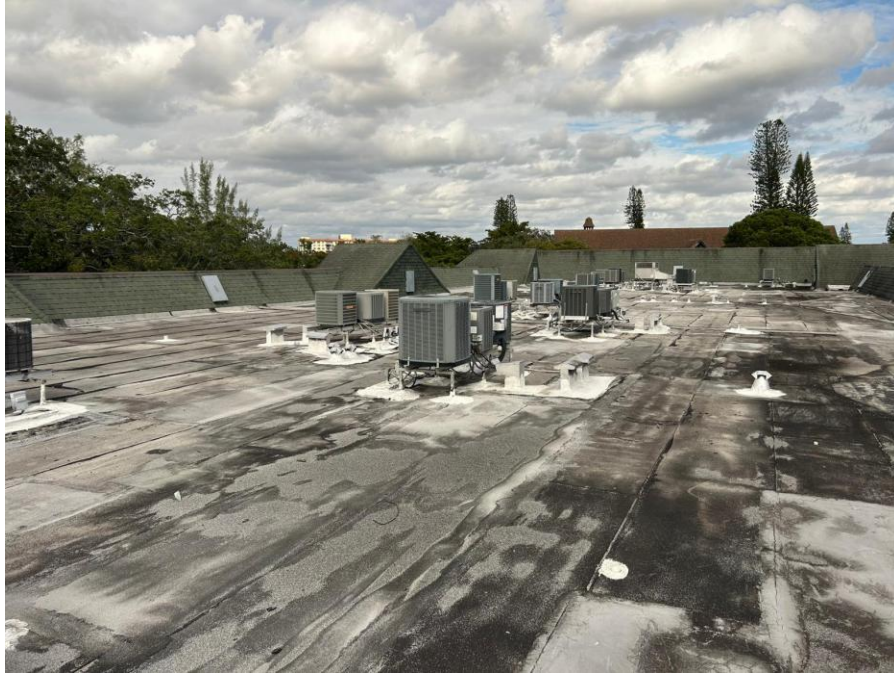
*Photograph 7 – View of rooftop with multiple HVAC units and visible signs of wear, including patch repairs and weathered surfaces.*

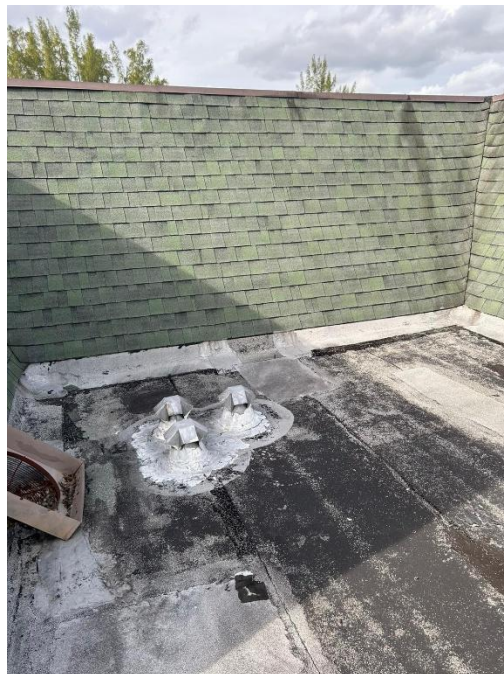
*Photograph 8 - Mansard roof with green asphalt shingles showing discoloration and signs of aging, highlighting potential moisture retention and the need for maintenance at the transition to the flat roof.*
