**International Village Association, Inc.**  
**SIRS Components**  
***Lauderhill, FL***

Report #: 40306-1  
Beginning: January 1, 2026  
Expires: December 31, 2026

**RESERVE STUDY**  
**Update "With-Site-Visit"**

March 3, 2025

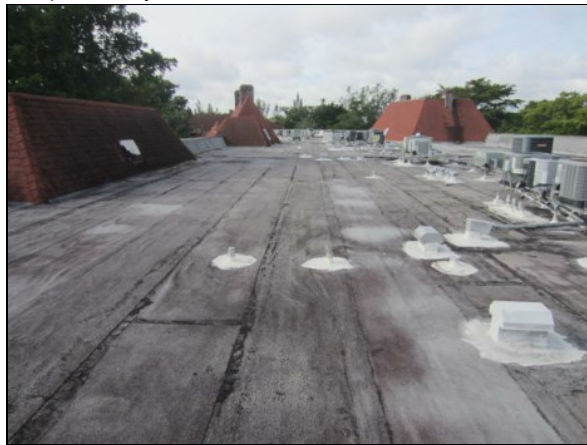
**Comp #: 2377 (3) Flat Roofs - Replace (2025)**

Useful Life:  
20 years

Remaining Life:  
19 years
