**FORM EB 18-2024
MILESTONE INSPECTION REPORT FORM**

Milestone Inspection

**International Village
Condominium, Grenoble
Building**

*3650 Inverrary Dr.,
Lauderhill, FL 33319*

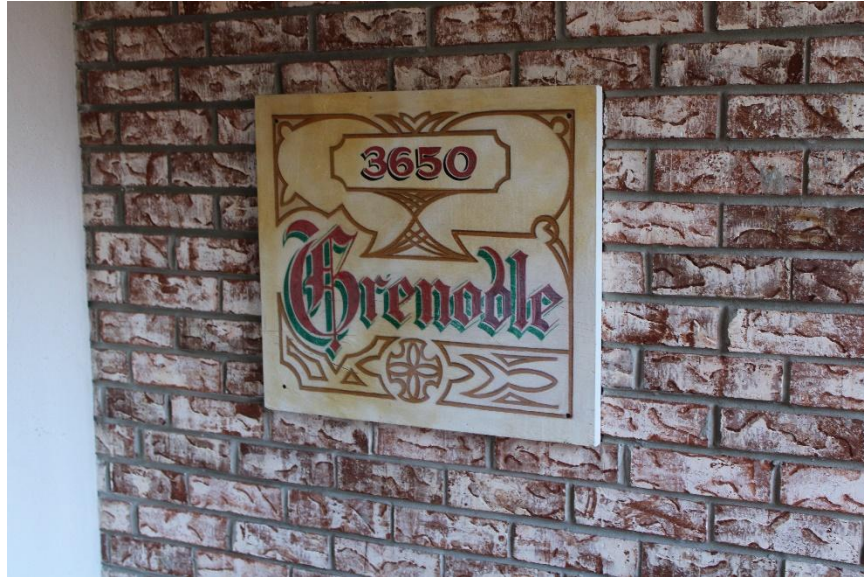
Photograph 1 – View of the main entrance.

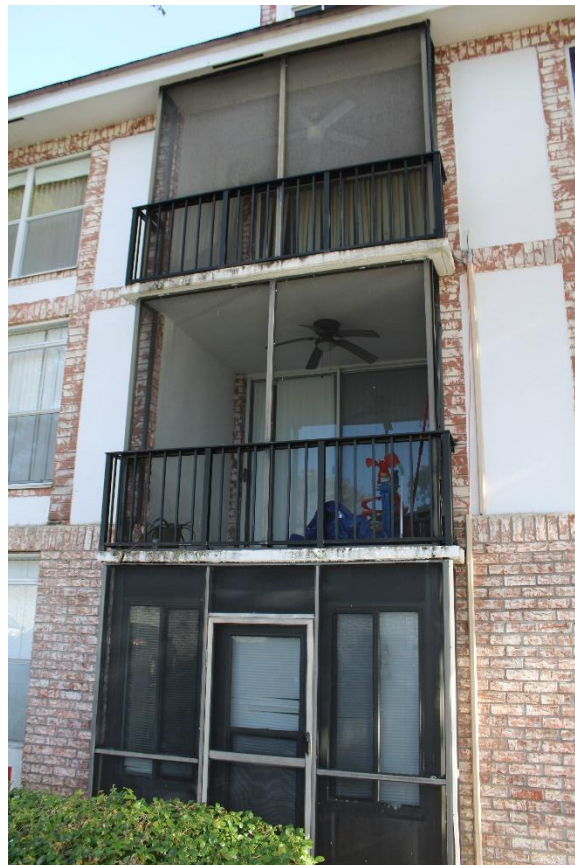
The balcony slab exhibits minor spalling, while the balcony edge shows significant spalling. The stucco on the walls has areas of spalling and minor cracks. The roof requires repairs, including addressing previous patches and prior repairs, which are showing signs of wear and deterioration.

Spalling was observed on the balcony slab edge, balcony slab, and stucco walls. The spalling at the balcony slab edge was significant, while the slab and stucco exhibited localized areas of minor to moderate spalling. No spalling was noted on beams or columns.

Photograph 2 – Typical view of the balconies and railing system.

1. None required _____
2. Required (describe and indicate acceptance)
Balcony spalls, wall stucco spalls and roof repairs are required.
