## PHASE 1 - Milestone Inspection

a. Name on Title: International Village Condominium - Yorkshire Building

b. Street Address: 3690 Inverary Dr, Lauderdale, FL 33319

Milestone Inspection

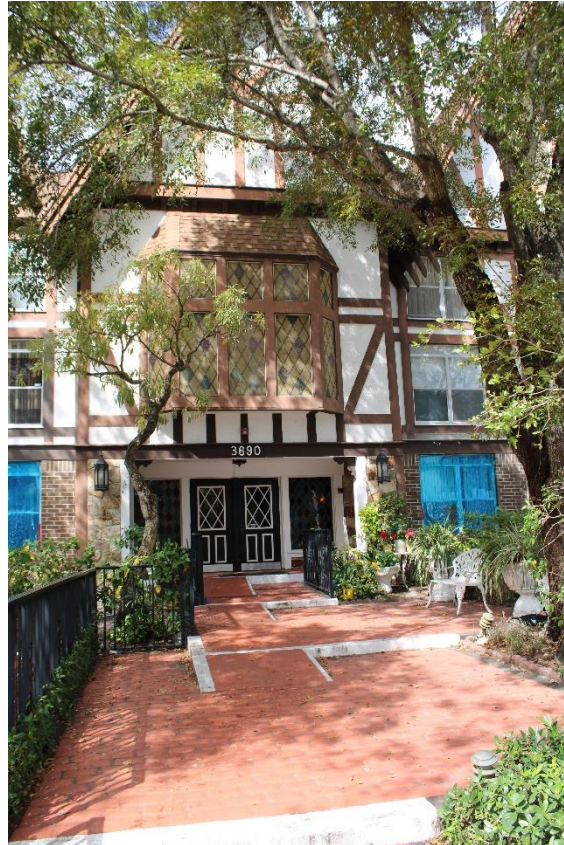
*Photograph 1 - View of the main entrance.*

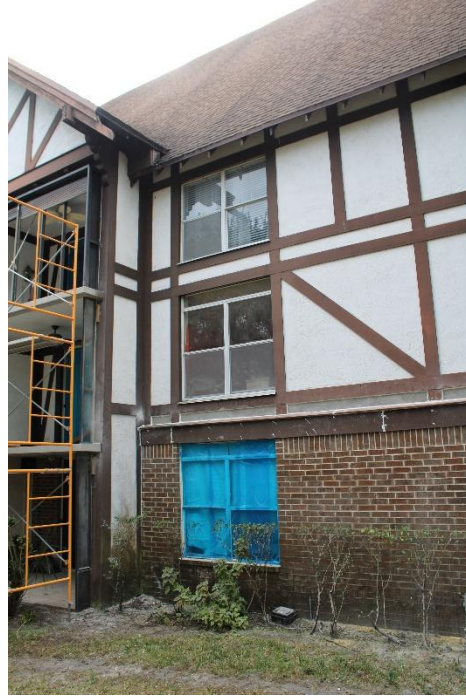
The exterior walls of the building feature a stucco finish with decorative stone accents, which are adhered to the wall using a mortar or adhesive bonding system. These elements are in good condition and appear secure.

*Photograph 3 - View of the building envelop, featuring a stucco finish combined with decorative stone cladding.*
