**International Village Association, Inc.**  
**SIRS Components**  
***Lauderhill, FL***

Report #: 40306-1  
Beginning: January 1, 2026  
Expires: December 31, 2026

**RESERVE STUDY**  
**Update "With-Site-Visit"**

March 3, 2025

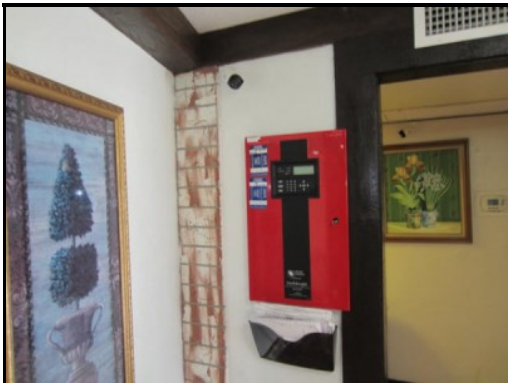
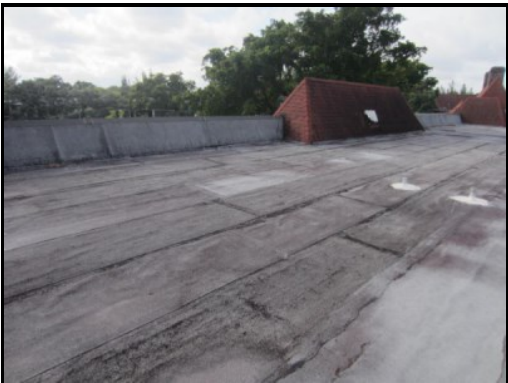
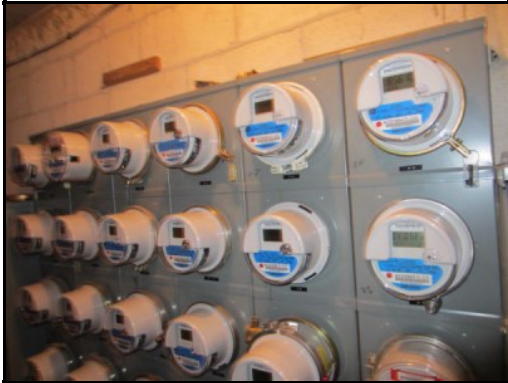
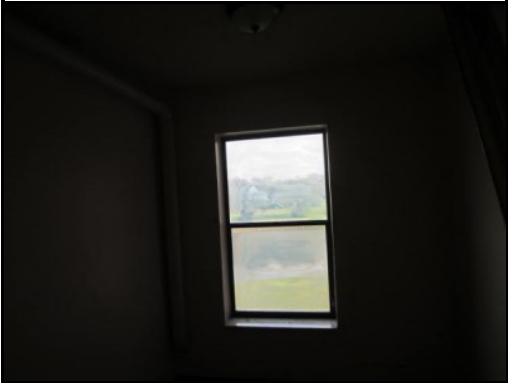
**Site Inspection Notes**

During our site visit on 1/14/2025, we visually inspected all common areas, amenities, and other components that are the responsibility of the Client. Please refer to the Component Details section at the end of this document for additional photos, observations and other information regarding each component.
