International Village at Inverrary

International Village Association, Inc.
Non-SIRS Components
Lauderhill, FL

Report #: 40306-1
Beginning: January 1, 2026
Expires: December 31, 2026

RESERVE STUDY Update "With-Site-Visit"

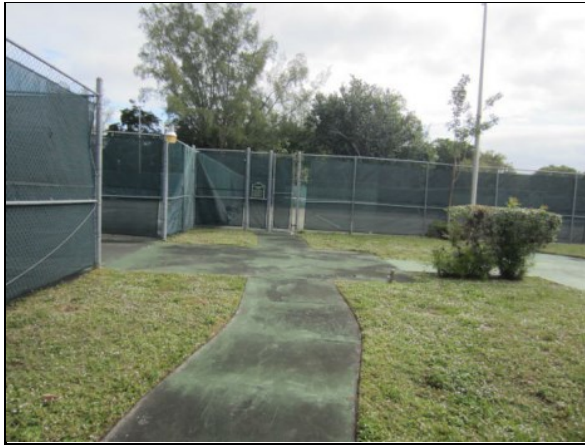
Useful Life:
40 years

Remaining Life:
0 years

Best Case: \$ 54,900

Worst Case: \$ 67,100

# Component	Useful Life (yrs)	Rem. Useful Life (yrs)	Current Average Cost
Site and Grounds			
2107 Concrete Areas (Tennis) - Repair	40	0	\$61,000
2123 Asphalt - Seal/Repair	4	0	\$90,450
2125 Asphalt - Resurface	24	7	\$904,500
2138 Wood Fencing - Repair/Paint	5	1	\$2,050
2139 Wood Fencing - Replace	20	6	\$16,400
2150 Fountain/Water Feature - Refurbish	10	0	\$16,000
2163 Concrete Bulkhead - 10% Repair	10	3	\$255,500
2169 Signs/Monuments - Refurbish/Replace	20	2	\$107,150
2175 Site Pole Lights - Replace	20	3	\$403,500
Clubhouse Interiors			
2709 Clubhouse Tile Flooring - Replace	30	5	\$57,100
2725 Aerobics Room - Remodel	15	0	\$7,975
2725 Weight Room - Remodel	15	0	\$11,185
2727 Fitness Eqpmt (Cardio) - Replace	10	0	\$50,250
2728 Fitness Eqpmt (Strength) - Replace	15	0	\$44,750
2746 Kitchen - Remodel	20	0	\$15,950
2749 Gym Bathrooms/Lockers - Remodel	20	0	\$41,500
2749 Hallway Bathrooms - Remodel	20	5	\$44,700

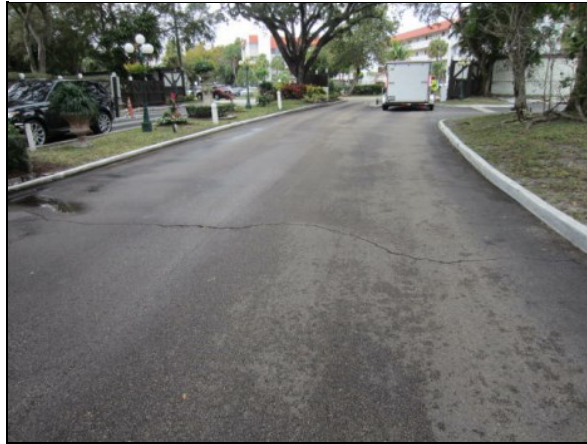
Useful Life:
4 years

Remaining Life:
0 years

Best Case: \$ 81,400

Worst Case: \$ 99,500

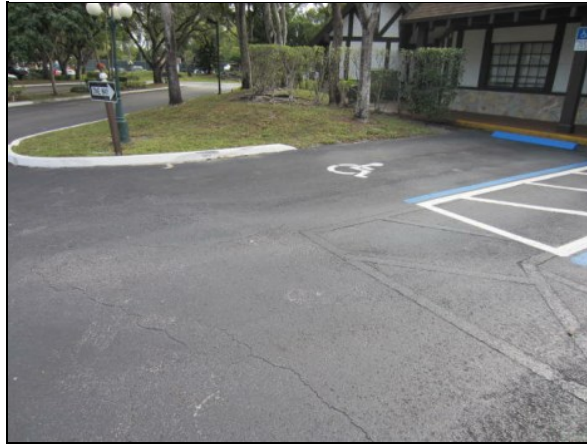
Useful Life:
24 years

Remaining Life:
7 years

Best Case: \$ 814,000

Worst Case: \$ 995,000

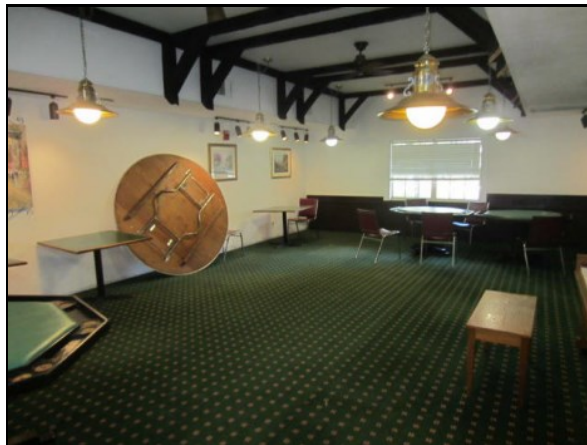
Poor condition: Card rooms determined to be in poor condition typically exhibit more advanced signs of wear and/or feature significantly outdated furnishings and finishes that should be replaced for aesthetic reasons, even if still in fair physical condition.

Card room remodeling costs may include refurbishment or replacement of game tables, chairs, lighting, furnishings, decor, etc., and will vary on scope of work. Remodeling projects should be anticipated at longer intervals to maintain a current, high-quality standard attractive to existing owners as well as potential buyers. Some Clients choose to work with design personnel to maintain a coordinated, attractive aesthetic. Costs can vary greatly depending on overall scope of work and types of finishes/furnishings selected. Unless otherwise noted, cost allowances shown below assume remodeling with both similar quantities and qualities as existing materials. Schedule and cost estimates should be re-evaluated during future Reserve Study updates and adjusted as needed based on any new information obtained and conditions evident at that time.

Useful Life:
20 years

Remaining Life:
0 years

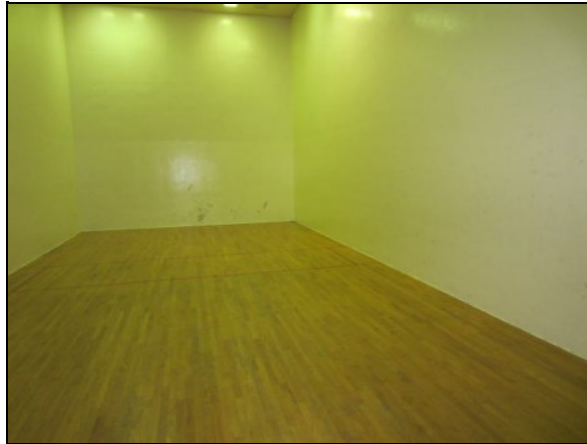
Comments: (2) racquetball courts with (1) small carpeted viewing area. All is in poor condition. Due to leaks, court refurbishment should be scheduled after roof replacement.

Poor condition: Racquetball courts determined to be in poor condition typically exhibit more advanced surface wear/deterioration, and may have damage that could affect play. Should be repaired and maintained to a high standard to restore good aesthetic appearance.

Racquetball courts should be inspected regularly for safety issues and repaired as needed through the Operating budget. At longer intervals, there may be a necessity for more substantial refurbishment (such as wall repairs, flooring replacement, painting, etc.). As such, we recommend that the Client plan for more substantial refurbishment at the approximate interval below. However, timelines for repairs/refurbishment can vary greatly depending on level of use, exposure to the elements, and aesthetic preferences of the Client. Thus, this component should be re-evaluated during future Reserve Study updates based on the most current information and conditions available at that time.

Useful Life:
15 years

Remaining Life:
0 years

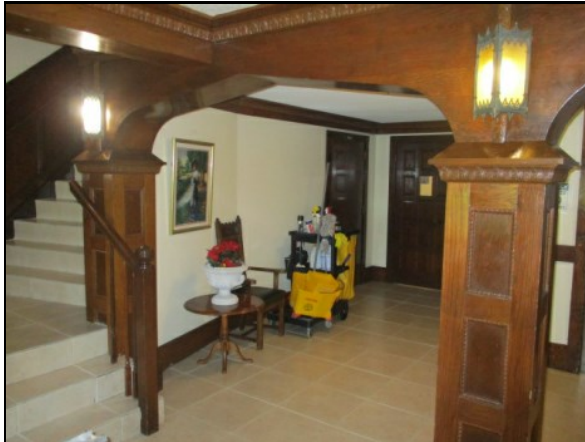
Comments: Poor condition: Interior areas determined to be in poor condition typically exhibit concerns such as physical deterioration (peeling, cracking, etc) or are no longer upholding aesthetic standards. Even if appearance is still fair, repainting may be warranted/recommended due to timing of other interior projects.

Regular cycles of professional painting are recommended to maintain appearance. Small touch-up projects can be conducted as needed as a maintenance expense, but comprehensive painting of interior areas will restore a consistent look and quality to all areas. Best practice is to coordinate at same time as other interior projects (flooring, furnishings, lighting, etc.) whenever possible to minimize downtime and maintain consistent quality standard.

Useful Life:
10 years

Remaining Life:
0 years

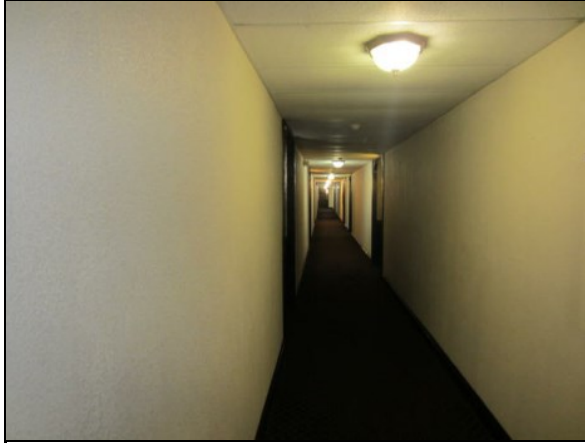
Comp #: 2705 Interior Lights - Replace

Comments: Poor condition: Interior lights determined to be in poor condition typically exhibit more significant signs of wear/abuse, often in higher traffic areas, and/or have become outdated and should be replaced for aesthetic reasons.

As routine maintenance, inspect, repair and change bulbs as needed. Best practice is to coordinate at same time as other interior projects (especially painting) whenever possible to minimize downtime and maintain consistent quality standard. Timing of replacements is ultimately subjective. Estimates shown here are based on our experience with similar properties and general aesthetic qualities. A wide variety of fixture styles is available; unless otherwise noted, funding recommendations are based on replacement with comparable quality fixtures.

Useful Life:
20 years

Remaining Life:
0 years

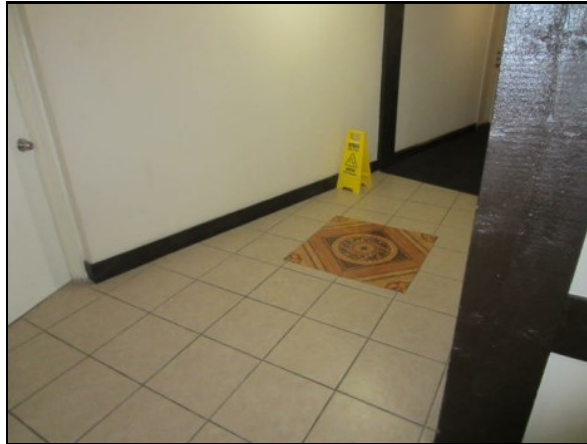
Comp #: 2709 Tile Flooring (2025) - Replace

Comments: *NOTE (2025): Tile Flooring to be replaced at (6) buildings in 2025. Remaining (5) buildings reportedly scheduled for 2026.

Fair condition: Interior tile flooring determined to be in fair condition typically exhibits some routine signs of wear and age, possibly including sporadic cracks and damaged grout. Style is still appropriate, but tile is showing more noticeable signs of deterioration.

As part of ongoing maintenance program, inspect regularly and repair or replace damaged sections as needed. If available, best practice is to keep a collection of replacement tiles on hand for partial replacements. With ordinary care and maintenance, tile in interior locations can last for an extended period of time, but replacement is often warranted eventually to enhance and restore aesthetic appeal in the common areas. Replacement costs can vary greatly depending on size and type of tiles selected. Our recommendation is to replace at the approximate schedule shown here.

Useful Life:
20 years

Remaining Life:
19 years

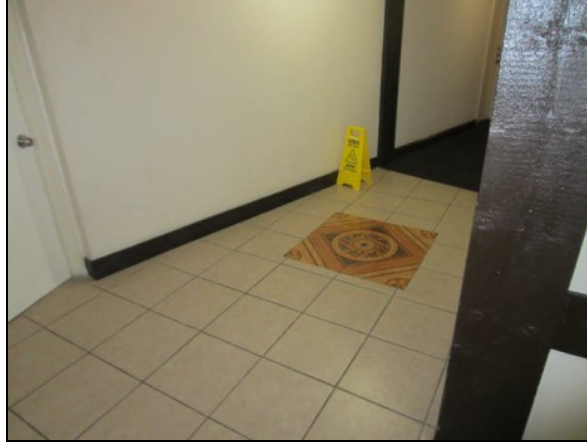
Comp #: 2709 Tile Flooring (2026) - Replace

Comments: *NOTE (2025): Tile Flooring to be replaced at (6) buildings in 2025. Remaining (5) buildings reportedly scheduled for 2026.

Please refer to the prior component (#2709) in this series for more general information and commentary on tile flooring replacement. The useful life, remaining useful life, and cost range for this specific component are provided below.

Useful Life:
20 years

Remaining Life:
0 years

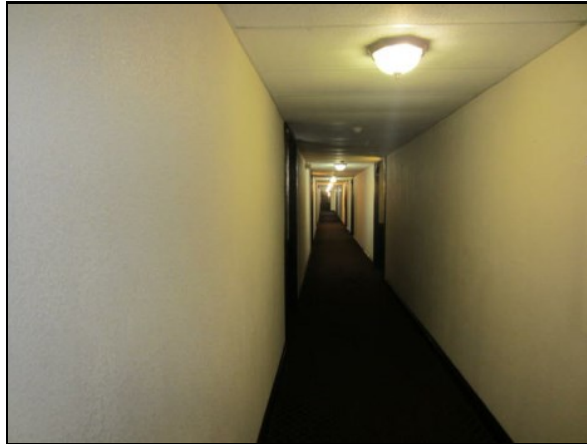
Comp #: 2711 Carpeting (2025) - Replace

Comments: *NOTE (2025): Carpeting to be replaced at (6) buildings in 2025. Remaining (5) buildings reportedly scheduled for 2026.

Poor condition: Carpeting determined to be in poor condition typically exhibits moderate to advanced signs of wear and age, such as consistent tread patterns in many areas, advanced color fade, and/or other physical deterioration. Condition may also be determined by aesthetics, if the carpeting is outdated and should be replaced with more current design.

As part of ongoing maintenance program, vacuum regularly and professionally clean as needed. Best practice is to coordinate at same time as other interior projects whenever possible to minimize downtime and maintain consistent quality standard. Timing of replacements is ultimately subjective. Estimates shown here are based on our experience with similar properties and general aesthetic qualities.

Useful Life:
10 years

Remaining Life:
9 years

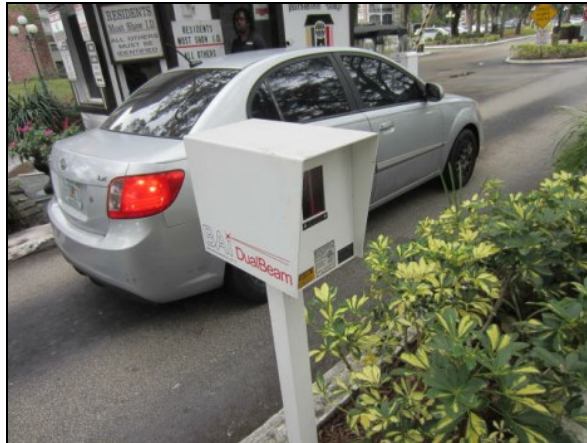
Comp #: 2507 Barcode Reader - Replace

Useful Life:
15 years

Remaining Life:
9 years

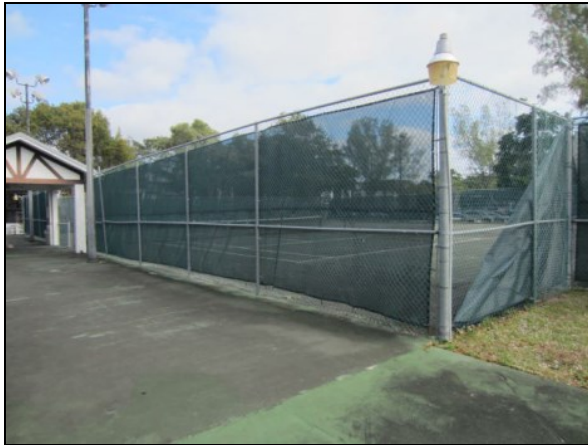
Comp #: 2813 Tennis Court Fencing - Replace

Fair condition: Tennis court fencing determined to be in fair condition typically exhibits more noticeable surface wear such as cracking or peeling of vinyl coating on chain-link mesh. Posts may exhibit some rust and deterioration but overall, fencing is intact, upright and stable.

Tennis court fencing should have a very long life expectancy assuming proper design and installation, lack of vandalism/abuse, etc. Best practice is to coordinate replacement with other major projects, such as court resurfacing, lighting replacement, etc. Vinyl-coated chain link fences normally have a longer life expectancy and are more attractive than those without. Gates and locks should be inspected and repaired as needed as an Operating expense in order to restrict access (if desired) to the tennis court. Costs shown here are based on complete replacement of mesh/fabric as well as poles/framework.

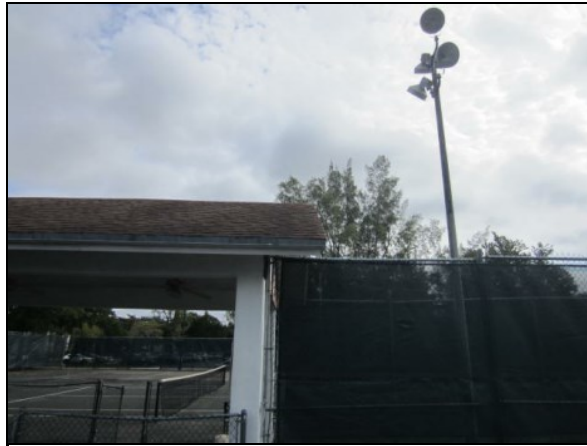
Comp #: 2817 Tennis Court Lighting - Replace

Poor condition: Tennis court lights determined to be in poor condition typically exhibit advanced, noteworthy surface wear and weathering, often including rust and deterioration of metal surfaces, especially if maintenance and repainting has been neglected. Lights may still be functional at this stage, but replacement is often warranted to maintain good curb appeal and uphold appropriate aesthetic standards for the property.

Observed during daylight hours; assumed to be in functional operating condition. As routine maintenance, inspect, repair/change bulbs as needed through the Operating budget. Best to plan for replacement of all lighting together at roughly the time frame below for cost efficiency and consistent quality/appearance. Based on evident conditions, repair/replacement history provided by the Client, and/or original installation date, comprehensive replacement is recommended at the approximate interval shown below. In most cases, best practice is to coordinate replacement with other sport court projects, such as court resurfacing, rebuilding, and/or fencing replacement. Unless otherwise noted, cost estimates shown below assume replacement with similar type, quality, and quantity as existing.
